Corrosion Study of Galvanized Ultra High Strength Steel Reinforced Overhead Transmission Conductors

Amir Azam Khan^{1*}, David Bong Boon Liang², Andrew Ragai Henry Rigit¹, Lim Soh Fong³, Al-Khalid Othman²

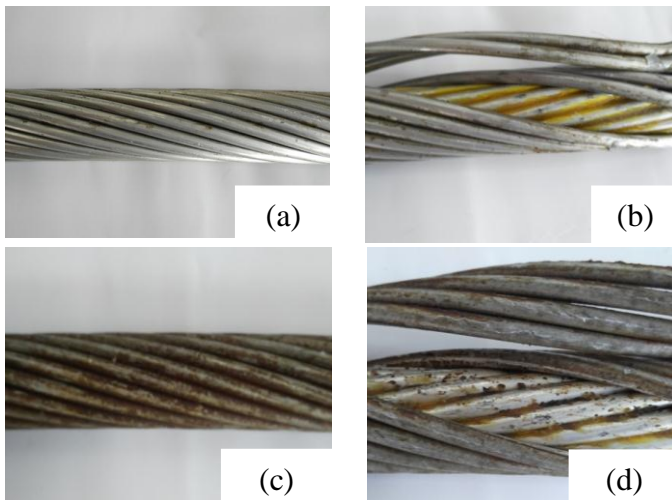
The as received wires were cut into specimens of about 9 inches and cleaned from dirt and grease. On first visual inspection the grease on used conductors was much dry and black in color. Figure 2 shows the picture of inner structure as observed through naked eye.

Figure 2: Outer construction of the ACSR conductor (unused (a) and used (c)). Aluminum strands are in spiral form. (b) and (d) show the status of inner layers. Degradation in the grease quality is obvious.

Upon visual inspection the grease on the outer layer for used conductor is relatively dry and dark spots are visible compared to the unused one. Further observation of the interior layer reveals that the grease exists but its quantity is less than the grease inside unused conductor. This is understandable as temperature changes and weather effect tends to degrade and contaminate the grease.

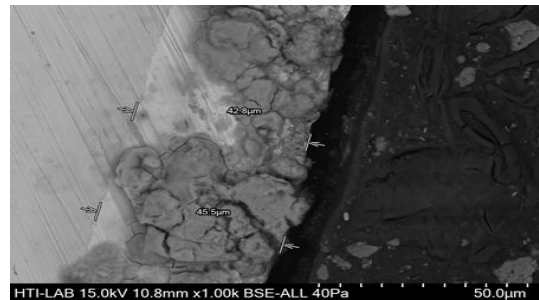
Figure 3 below presents an SEM image of polished steel strand from the ACSR330 conductor. This shows the state of zinc coating produced through galvanization on an unused conductor. The image has been taken by FE-SEM where the electron beam is produced through schottky effect Field Emission Gun. Such samples are very difficult to polish as the steel substrate is very strong and hard whereas the zinc coating is very soft. In order to obtain uniform polishing on both surfaces, it is very difficult to conduct polishing for a longer time, in detriment of polishing debris. The section is polished after mounting on a resin base. The resin debris can be seen accumulated on the coating edge due to its detachment from the mount. The image demonstrates a clean and smooth coating-steel interface, and the coating thickness is more or less uniform. The coating thickness varies between 42 to 45 μm.

Figure 3: SEM image of polished surface of unused steel wire cross section.

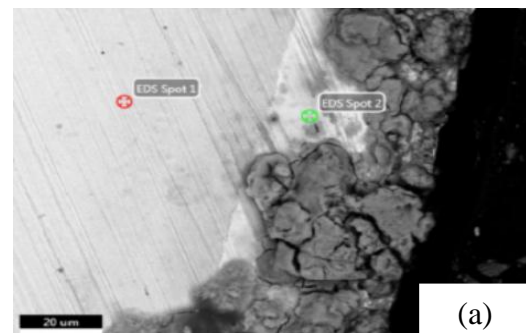
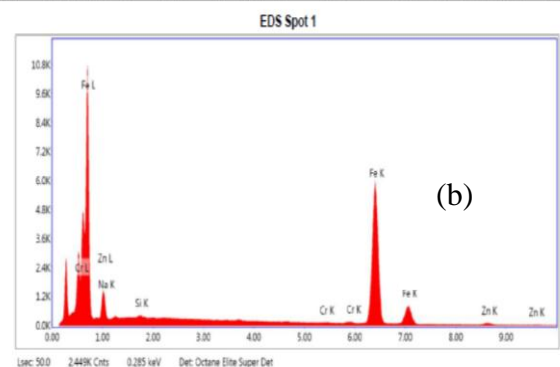
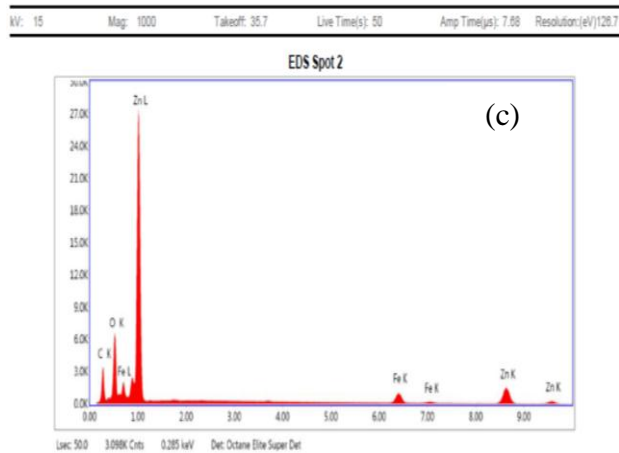
Figures 4 (a), (b) and (c) show the spot EDAX analysis on the same image with precise spot position as indicated. It can be seen that the spot 1 is mainly composed of Fe with traces of chromium, carbon, Na and Zn (Figure 4 (b)). The presence of Zn at this spot can only be explained by the fact that during polishing, soft particles of zinc can detach and get deposited onto the steel surface. In Figure 4 (c) it is evident that the spot 2 is mainly composed of pure zinc.

Figure 4: (a) SEM image of the polished surface of unused Steel wire cross section indicating the two spots of EDAX (b) Elemental spectra for spot 1 produced through EDAX (c) Elemental spectra for spot 2 produced through EDAX

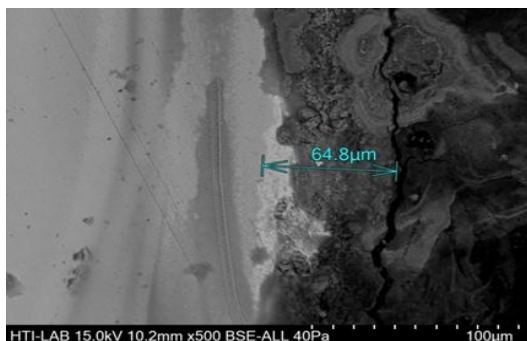
Figure 5 reveals a very interesting micro structure. This is the SEM micrograph of the same galvanized steel strand but which has been in service for about 30 years. The high temperatures produced through thermal effect of high voltage and current combined with the time effect resulted in diffusion and counter diffusion of zinc coating into the steel conductor and diffusion of elements within steel into the zinc coating. The interface can be seen highly distorted and highly diffused, the coating thickness has changed, strikingly, the thickness has increased. This increase in thickness resulted in the dilution of zinc inside the coating.

Figure 5: SEM image of the polished surface of used steel wire cross section.

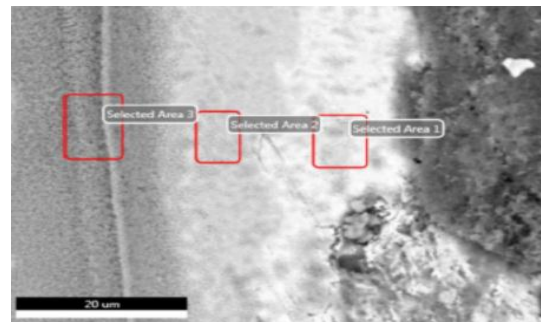
Figure 6 presents the same polished surface under higher magnification and three areas are selected for Elemental analysis, Area 1, Area 2 and Area 3, represented by the red color rectangles. Area 1 is well inside the coating, Area 2 is between the coating and the substrate, whereas the area 3 is within the Steel substrate. The EDS results are shown under Figure 7 (a), (b) and (c). The Figure 7 demonstrates clearly that under the action of time, heat and cyclic stresses, the zinc has diffused into the steel. The coating thickness has now increased to about 65 microns at first sight, but actually, the zinc presence can be detected at a much longer distance into the steel core. The EDAX area scans give evidence that significant quantity of Zn has diffused into a distance of up to 130 μm into the steel boundary. Meanwhile Fe is also detected within Zn coating. This is a phenomenon produced as a result of counter diffusion of the two species, Fe and Zn.

Figure 6: SEM image of the polished surface of used Steel wire cross section indicating the three selected areas for EDAX

One very interesting feature observed in Figures 6 and 7, where the diffusion of Zn appears to create bands of concentration in which the concentration of Zn appears to increase and decrease in a wave like fashion. A very similar phenomena is observed in mineral deposits, which occurs over a much longer period of time, named *Liesegang* bands after the famous scientist who discovered it in 1896. Several researchers have studied this phenomenon in minerals (Kulkarni S.D. *et al*, 2017, Rajurkar N. *et al*, 2015, George J. *et al*, 2005 and George J. *et al*, 2003) but in metals this phenomenon has not been studied so far.

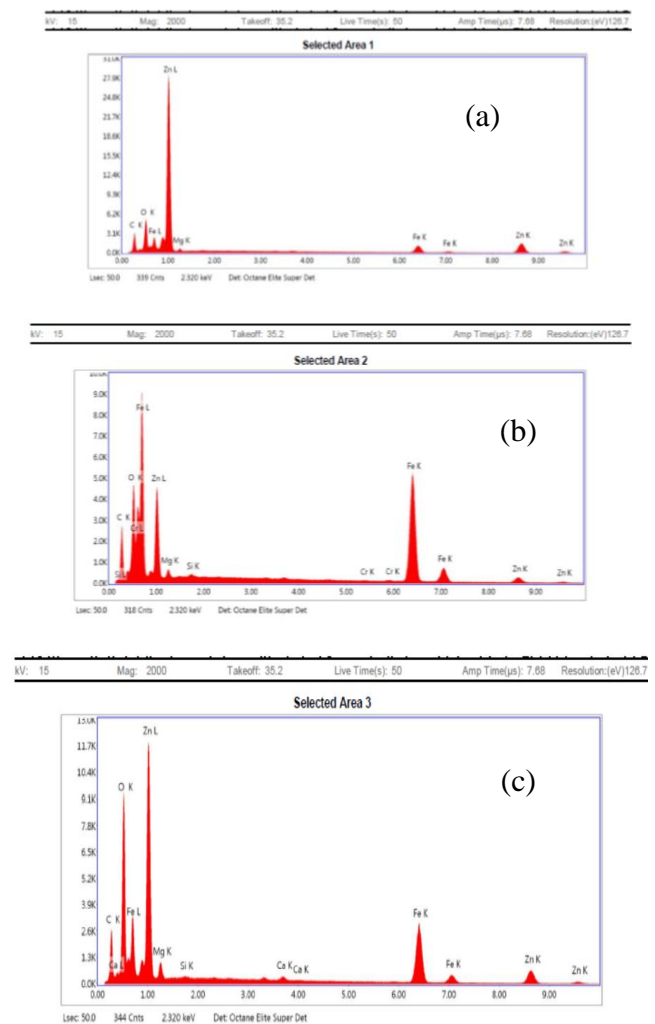
Figure 7: (a) Elemental spectra for Selected Area 1 produced through EDAX (b) Elemental spectra for Selected Area 2 produced through EDAX (c) Elemental spectra for Selected Area 3 produced through EDAX.

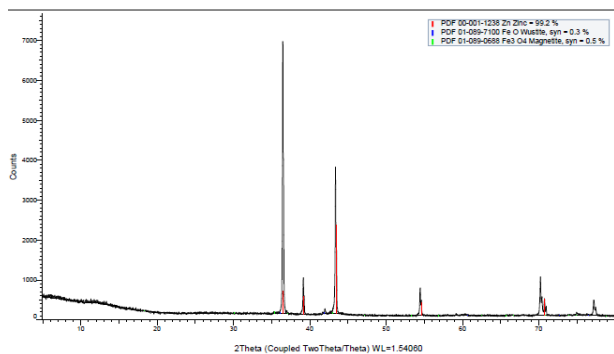
Figure 8 shows that the surface coating on unused ACSR conductor steel wire contains 99.2% zinc. The zinc coating in this sample is almost unaffected as also demonstrated in EDAX results (Figures 4 (a), (b) and (c)). The total oxide content is less than 0.5%, which can be considered as negligible. On Figure 9 the XRD spectrum of used Steel wire surface is presented. In this figure the zinc content on the surface of the coating drops from 99.2 to 90%. There is presence Chromium Carbide (8.5%) which is believed to have diffused out of the steel core (Counter diffusion with Zn). This confirms the initial finding through FESEM and EDAX (Figures 7 (a), (b) and (c)) that Zn has migrated into the steel core and elements from steel have counter diffused towards outside surface. This has happened over a long period of 30 years of heating and cooling within acceptable temperatures. The total oxide found on the strand surface is less than 1%.

Figure 8: XRD patterns of the galvanized surface of unused steel wires from ACSR330 conductor.

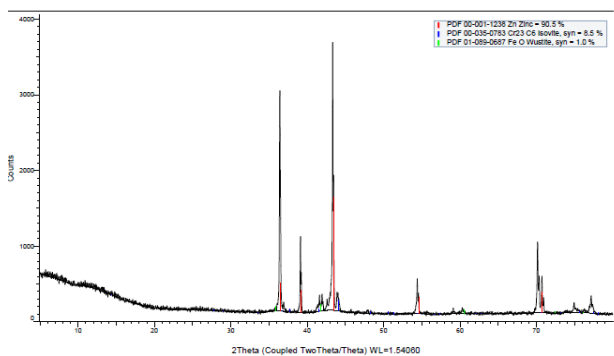
Figure 9: XRD patterns of the galvanized surface of used steel wires from ACSR330 conductor.
