Assessment of the Structure Failure of the Palm Oil Mill Effluent (POME) Digestion Tank Constructed on Peat Soil

Abstract

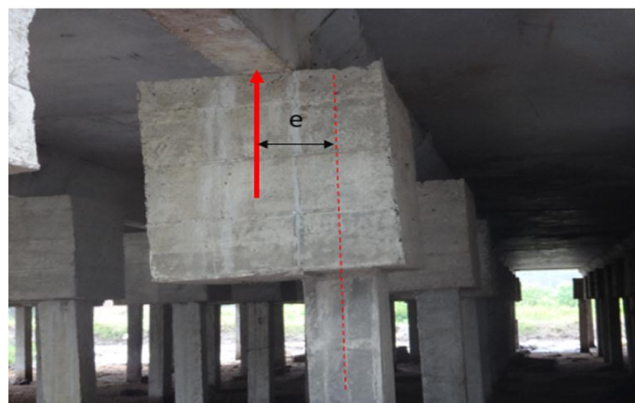
Defect mapping was carried out on the structures to establish the type, shape and extent of defects experienced by the structures. The information on the type, shape and extent of the failures/defects being experienced by the structures. The mapping revealed that almost all piles deviated from their intended position, almost all piles inclined, the existence of gap between beams and pile caps and many piles were found to have crack close to pile cap. Mohammad et. al [6] stated that the most probable cause of the pile deviation was due to the displacement of soft ground. Furthermore, the deviation was also expected to be caused by negligent in carry out the setting out survey for the pile position.

Furthermore, the piles were designed to directly support the beams and in turn support the RC platform where the POME tanks are resting. However, at the site most of these piles have deviated/offset from their intended position as shown in Figure 3. To transfer the load from the beams to the deviated piles, pile caps were constructed that extend from the piles up to the intended pile positions. In doing so the pile caps also act as a cantilever beam. This arrangement of pile caps has induced moment on to the piles. Generally, in the design, allowance should be made to cater bending stresses due to eccentric or lateral loading and to eccentricity caused by deviations in the straightness and inclination of a pile [7].

Fig. 3: Pile deviated from its intended position

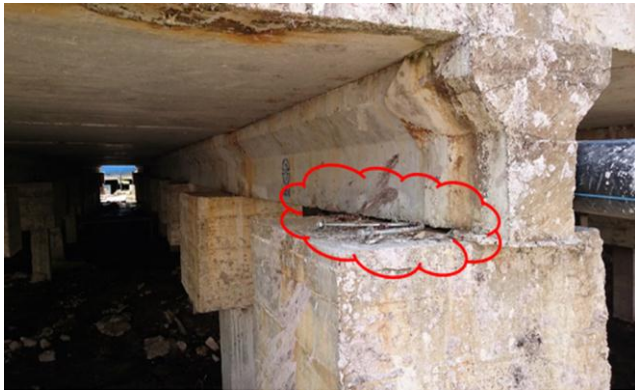
In certain locations, the beams are not resting properly on the pile cap creating a gap as shown in Figure 4 and thus, the load at these piles are being transferred to the neighbouring piles along the 2.75 m span beams.

Fig. 4: Gap between pile cap and pre-cast beam

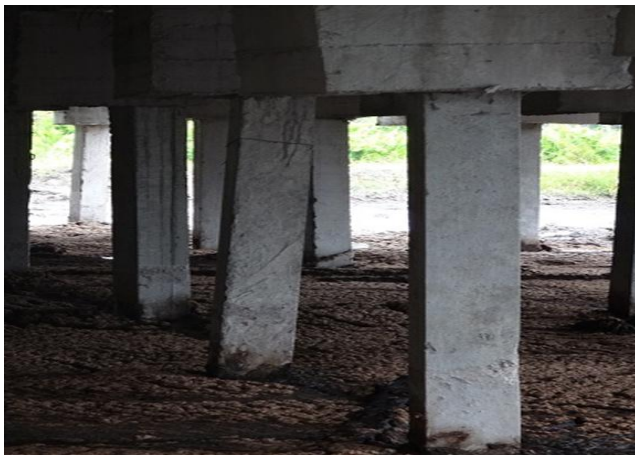
To understand the extent of the deviation of these piles, all the piles of the Tank No. 2 was surveyed at ground level and just beneath the pile cap level to establish their position. The range and percentage of piles deviated at pile cap level are 10 to 680 mm and 100 %, respectively. In addition to the above and based on survey data the inclination of each pile was also established and the type of inclination is shown in Figure 5. The range of the inclination of the piles are between 0 to 21.4 degree.

Fig. 5: Typical of existing inclination of pile

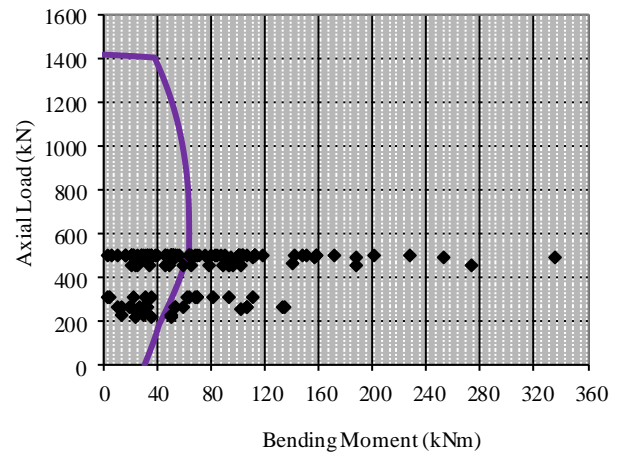
To establish the failure/collapse mechanism, the induced moment and induced axial on the piles due to the different loading of the POME digestion Tank No. 2 were checked against the allowable moment capacity and bearing capacity of the individual pile at the existing state. Harries [8] stated that moment capacity at the pile-to-pile cap interface is determined from the moment capacity of the pile. The result of this analysis is presented in Table 2. The typical plotting of induced axial load and moment on each pile on the diagram of axial-bending moment capacity of the piles at 100% loading is presented in Figure 6.

Fig. 6: Plotting of induced axial load and moment on each pile on diagram of axial-bending moment capacity of the piles Tank No. 2 at 100% loading.

Based on the above, it seems that at 100 % loading the piles of Tank No. 1 and Tank No. 2, would most likely fail due to induced moments that exceeded allowable moment capacity of the piles and induced axial loads exceeded bearing capacity of the piles.

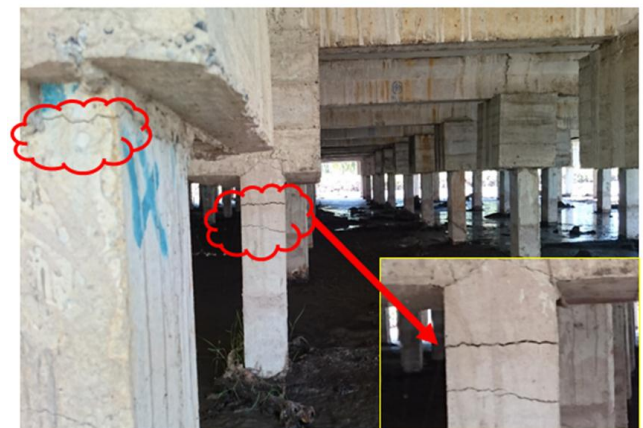
The crack found on certain piles just beneath their pile cap as shown in Figure 7 affirmed the failure due to the moment.

Fig. 7: Crack underneath of pile
