# Slope Stability Analysis of Granitic Residual Soil Using SLOPE/W, Resistivity and Seismic

RC Omar<sup>1\*</sup>, INZ Baharuddin<sup>2</sup>, Hairin Taha<sup>3</sup>, R.Roslan<sup>4</sup>, Hazwani NK<sup>5</sup>, Muzad MF<sup>6</sup>

<sup>1,2,3,4,5</sup> Institute Of Energy Infrastructure,

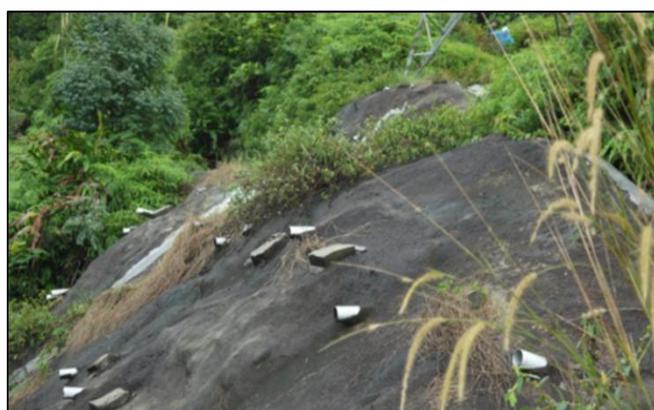
Fig. 2: Treated slope using grouted nails and cement grouting

The geophysics surveys including resistivity and seismic studies were conducted along the line located at 4°23’37.4’’ N latitude and 101°36’13.6’’ E longitude on the slope to obtain the subsurface information. Table 1 showed the coordinates of the survey line. A slope failure has occurred two years ago due to heavy rainfall and landslide. After the incident, slope rehabilitation was implemented by constructing retaining wall using soil nailing method and cement grouting to reinforce the slope since the method was effective and economical [14]. Figure 2 showed the treated slope using soil nailing method.

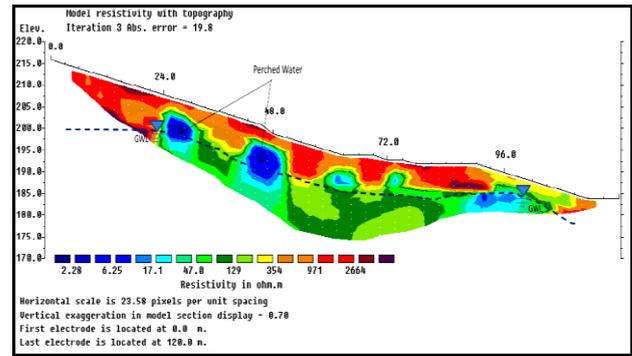
Fig.3: 2D Resistivity model of study area

Based on the resistivity survey, the existence of groundwater level has been found at a depth of 10.0 m from ground level. Generally, the subsurface is made up of sandy soil from weathered granite which range of resistivity value from 351 Ohm-m to 2670 Ohm-m. The stiff to very stiff layers of Sandy CLAY were interpreted 10.0 m below the surface around the tower with range of resistivity value 41 Ohm-m to 130 Ohm-m. The Standard Penetration Test (SPT-N) and Rock Quality Designation (RQD) for soil and rock types in Table 3 have been interpreted at 1.5 m depth from the surface level based on the depth of borehole. This area consists entirely of weathered rock with RQD values of 25% to 50%, only a quarter of the area with RQD values of 50% to 75%. The stiff to very stiff soils were discovered at 10.0 m depth with SPT-N values 9 to 26.

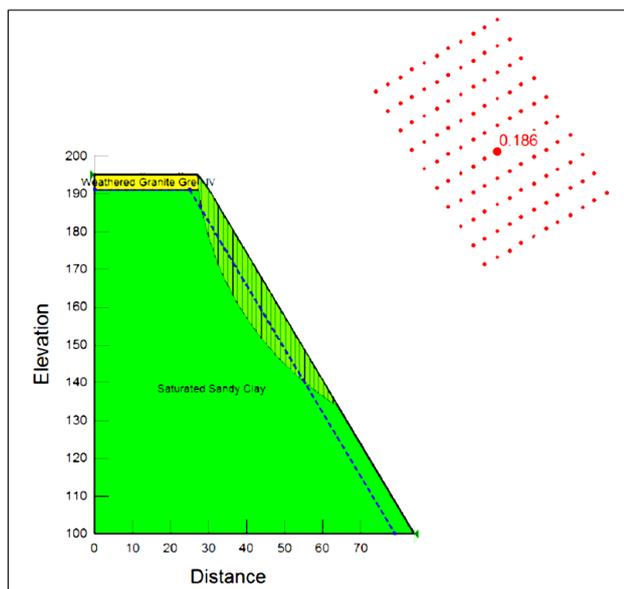
**Fig.4:** FOS model of study area.

SLOPE/W analysis was processed based on geophysics analysis; resistivity and seismic as well as laboratory testing. From this analysis, the slope was predicted to be unstable based on FOS value which was 0.186 according to the guideline of slope stability. Table 6 shows the parameters of SLOPE/W analysis that generates FOS as shown in Figure 4.

From the geophysics analysis, Weathered Granite Grade V with RQD values of 25% to 50% was detected at the surface of the slope. The Sandy CLAY that has SPT-N values from 1 to 26 was discovered at 5.0 m to 10.0 m depth. Factor of safety for the slope was 0.186 which is less than 1.0 indicating the instability of the slope condition. The actual slope circle failure has already taken place at the study site and the soil nailing was installed to prevent further slope failure. The study area was also experiencing soil erosion on the surface due to the existence of small gully that has developed previously. Following these observations, erosion control measures should be carried out to prevent or reduce movement of eroded soil sediments off-site or land. The controls often involve the creation of a physical barrier, such as vegetation cover or rock, to absorb some of the energy of water that is causing the erosion.

Constant monitoring should be carried out on existing slope to prevent the recurrence of slope failures. Field monitoring provides the information and new insights on the condition of the slope [18]. The existence of groundwater level has been found at a depth of 10.0 m from ground level. During rainfall, the possible increase of groundwater level can reduce the strength of soil, thus this can affect the stability of the slope [19]. In previous cases of slope failures, a very high water table was identified as the most common cause of slope failure.

which failure mechanisms can form in the ground or within the soil-nailed system, or when movement of the soil-nailed system can lead to severe damage to its structural elements or nearby structures and facilities. For this area, the design of a soil-nailed system should be ensured that there is an adequate safety margin against all the perceived potential modes of failure. The environmental conditions should be investigated at the design stage to assess their significance in relation to the durability of soil nails. Appropriate measures should be applied to the soil nails such that an adequate safety margin of the soil-nailed system can be maintained throughout its design life. Doing so, the risk of slope failure in the study area can be minimized.
