A Study on Appearance Checks for Structures with UAV-Based Spatial Imagery Information

Dong-Moon Kim*

*Department of Spatial Information Engineering, Namseoul University, 91, Daehak-ro, Seonghwan-eup, Seobuk-gu, Cheonan-si, Chungcheongnam-do, 31020, Republic of Korea

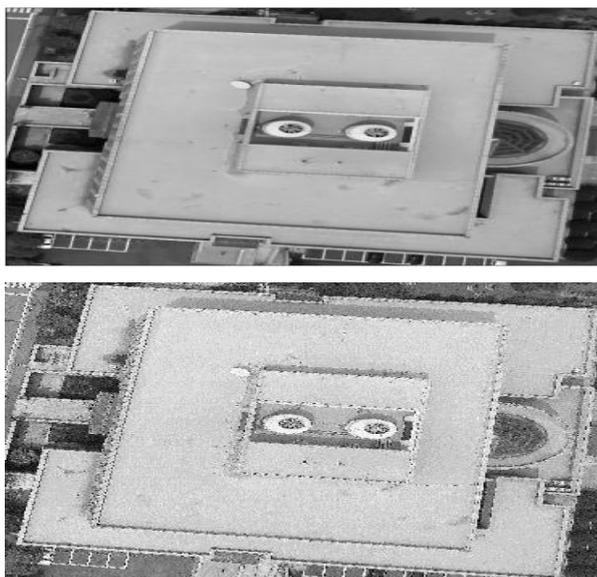
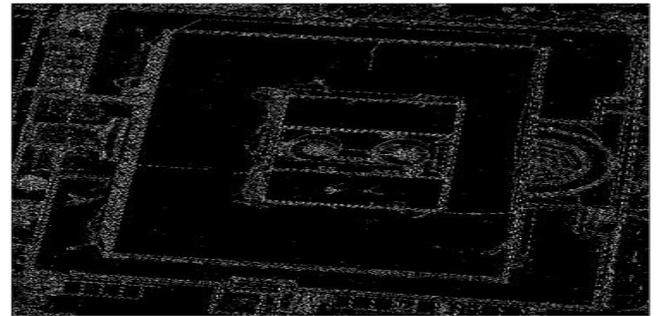
Figure 6: Binary Image **Figure 7:** Sharpening Image **Figure 8:** Edge Detection Image

An edge detection technique was applied to detect damaged parts in appearance including cracks with spatial imagery information. For the application of an edge detection technique, cracks were detected through image binarization, sharpening, contour search (edge detection), and noise elimination. Figure 6 shows the outcomes of image binarization; Figure 7 shows the results of sharpening to increase the efficiency of feature search in binary images; Figure 8 shows edge detection by applying an edge detection technique called Canny; and Figure 9 shows the detection of crack parks by getting rid of noises from the edge detection images.

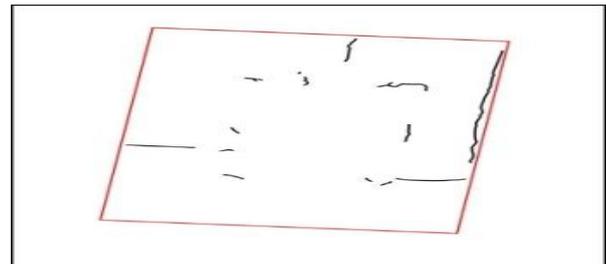
Figure 9: Detection of cracks after noise elimination

Figure 10 shows the locations of cracks detected in Figure 9 with an examination done with a naked eye to present the damage on the concerned part in a quantitative manner. Table 2 shows the measurements of cracks in width and length with steel tape and the arrangement of each section type. Detected in images, the types found in each section included cracks, white rust, scaling, and wire & cable. There were three cracks, two spots of white rust, six spots of scaling, and two spots of wire & cable.

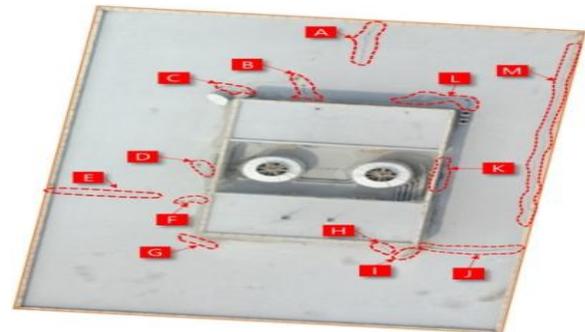
Figure 10: The locations of detected cracks

Section	Width (mm)	Length (mm)	Type
A	0.5	669	Crack
B	0.8	301	Crack
C	15	277	White rust
D	11	192	Scaling
E	0.5	739	Crack
F	5	149	White rust
G	7	251	Scaling
H	6	127	Scaling
I	10	156	Scaling
J	9	744	Wire & cable
K	20	501	Scaling
L	0.4	675	Scaling
M	9	3217	Wire & cable

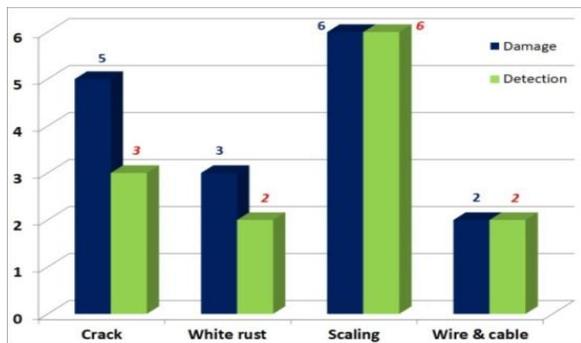
Figure 11: Field study results of cracks

An on-site inspection with a naked eye detected 100% of scaling and wire & cable spots, but some micro-cracks and white rust spots were not detected as seen in Figure 11. These micro-cracks and white rust spots were created within the depth of 1mm or less

from the building surface, being in the scope of having no impact to the structural damage of buildings. As seen in Figure 12, the shapes of detected cracks were diagonal (B) or perpendicular (A and E) to the joints with outer walls or walls in buildings.

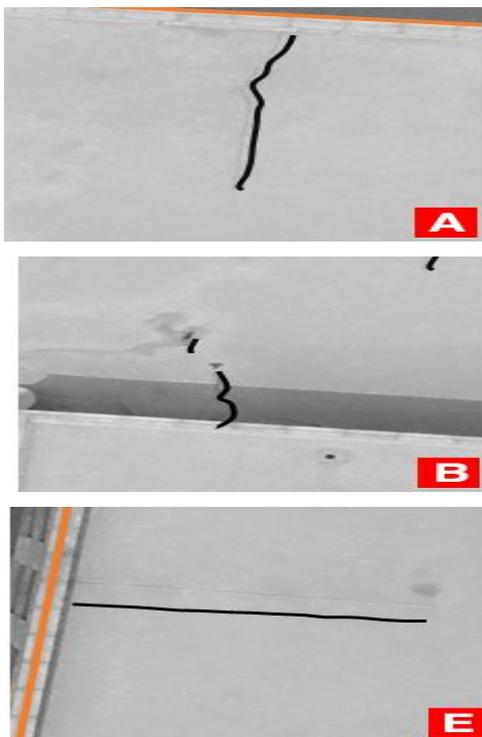
Figure 12: Shapes of detected cracks

The cracks recorded mean was 0.6mm in width and 569mm in length, measuring a minimum 301mm and maximum 739mm in length. As for the location of cracks, there were two cracks at the half point of the outer wall length and one crack at the one-third point of the wall length from the joint with the inner wall. These findings confirm the possibility that UAV-based spatial imagery information can be used as basic data to figure out cracks in buildings and serve various purposes in appearance checks to assess buildings for stability.
