Strengthening of Reinforced Concrete Beams Weak in Shear Using GFRP

Qudhan Shaik^{1*}, P. Polu Raju²

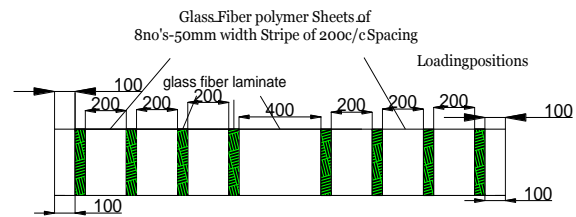
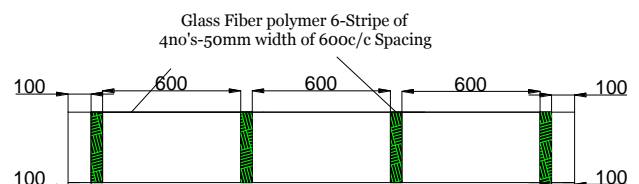
Fig. 3: Detailing of Retrofitted Specimens

The front view schematic diagrams of the second set of specimens are shown in Fig. 3 and details of the specimens are shown in Table 2

(a) Detailing of BWSRF-1

(b) Detailing of BWSRF-2

(c) Detailing of BWSRF-3

Font Size	Beam Specification	External Bounded GFRP Strips in Shear Span
1	BWSRF1	50 mm wide Strip @ 200mm c/c Spacing
2	BWSRF2	50 mm wide Strip @ 400mm c/c Spacing

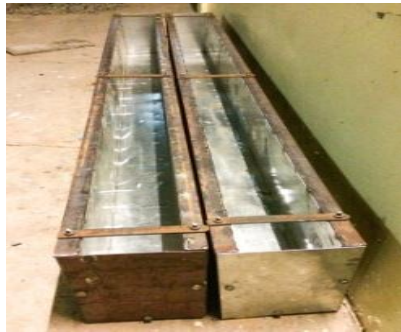
Fig. 4: Moulds

The fabricated moulds (Fig. 4) are prepared using Galvanized Iron (GI)-Sheets to get the mould in required shape and plaster powder was applied at corners of the mould to avoid slurry leakages.

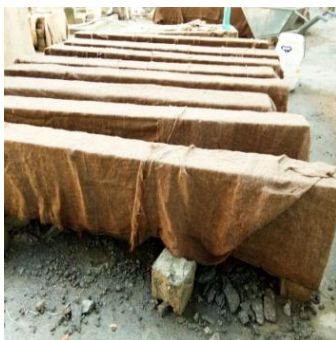
Fig. 5: Specimens Curing

All the specimens are cast and cured for 28 days. The grade of the concrete was M20. The design mix proportion was 1:2.35:3. The mix proportion was achieved as per design calculations considered in IS 10262:2009 [11]. The materials used were Ordinary Portland Cement (OPC), the coarse aggregates containing 70% of 20 mm aggregates and 30% of 10 mm aggregates, and the fine aggregates conforming to Zone-II. The water-cement ratio was 0.5. The specimens are cured with gunny bags as shown in Fig. 5. The laminated sheets are cut into required shapes are shown in Fig. 6. The GFRP laminated sheets which are having very good properties compared to others and less expensive. The properties of GFRP are shown in Table 3.

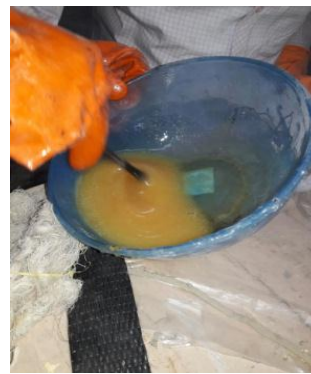
Fig. 7: A mixture of Epoxy Resin

Grinding process has been achieved using grinding machine at appropriate location on beams for GFRP sheets wrapping. The crucial part of strengthening procedure was done which was epoxy sap utilization. The epoxy resin consists of hardener and resin which was lapox L-12 and lapox K6 respectively. The mixture of epoxy resin and hardener with a ratio of 2:1 has to be mixed thoroughly stir for 10 to 15 minutes as shown in Fig. 7. The application of epoxy resin on the specimen as shown in Fig. 8. The properties of the two materials are shown in Table 2.

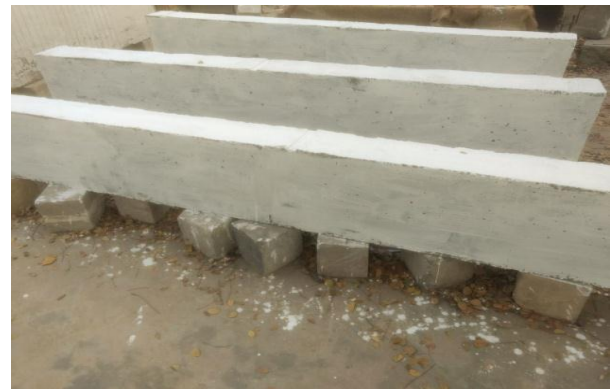
Fig. 9: Conventional Specimens

After application of epoxy resin, the pot life should be maintained for 30 minutes and ensure that the epoxy solution was formed into sticky form. Then, the GFRP strips are wrapped on the beams at required places. Application of GFRP was done using steel roller to avoid air voids. After 30 minutes of GFRP application, again apply the epoxy resin to the outer surface. To appear cracks clearly, whitewash has done to the specimens. The conventional and retrofitted specimens are shown in Fig. 9 and Fig. 10 respectively.

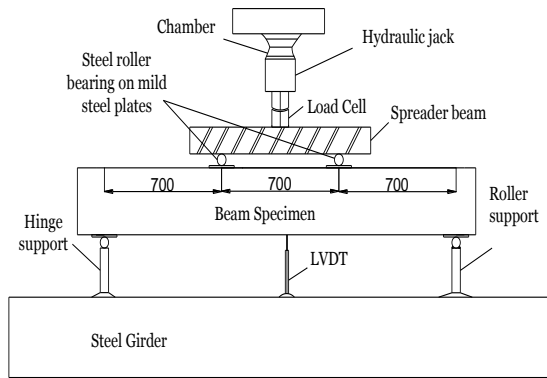
Fig. 11: Schematic Diagram of Test Setup

All the specimens were tested under the symmetrical two-point loading using loading frame having a capacity of 200 tons. The support conditions are one end was hinge support and the other was roller support. The linear variable differential transducer (LVDT) is placed linearly below the beam at load application using load cell through hydraulic jack of loading frame. The schematic diagram and actual test setup are shown in Fig. 11 and Fig. 12 respectively.

Two sets of beams were tested under the loading frame as a four-point loading. Beams are in simply supported condition. The supports were placed on a girder. The load is applied at two places which are 700 mm from the supports and the deflection is measured at the bottom of the beam by LVDT. Different parameters are analyzed after testing such as load versus deflection, mode of failure and crack pattern of all specimens. The comparison of conventional and retrofitted specimens is analyzed from the results.

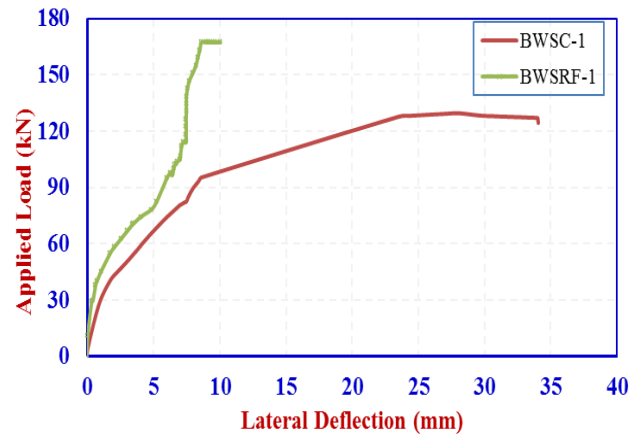
The Fig. 13 shows the load vs. deflection response of both BWSC1 and BWSRF1. The load carrying capacity for retrofitted specimen was more when compared to conventional specimen. The retrofitted beam was shown less deflection at higher loads. The ultimate load was significant for BWSRF1 about 167.24 kN and deflection was 10 mm whereas for BWSC1 the ultimate load was about 129.6 kN and the corresponding deflection was 30 mm. Therefore, the retrofitted specimen shows significant performance than conventional specimen.

Fig. 13: Load vs. Deflection curves for BWSC1 and BWSRF1.

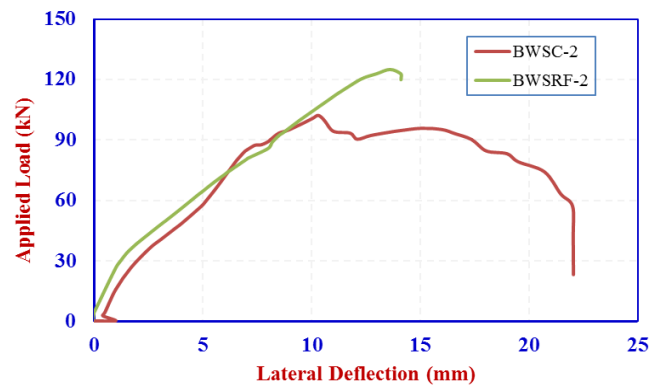
The Fig. 14 shows the 50% shear reinforcement reduction specimens designated as BWSC2 and BWSRF2. The BWSRF2 shows significant load carrying capacity even though the shear reinforcement was reduced as parameter in this study. The load deflection curve is gradually drops down after reaching the ultimate load. For BWSC2, the load carrying capacity was 125 kN and its deflection was about 13 mm whereas for BWSRF2, the ultimate load was 102.2 kN and the corresponding deflection is 11 mm. It shows that retrofitted specimen has significant load carrying capacity.

Fig. 14: Load vs. Deflection curves for BWSC2 and BWSRF2.

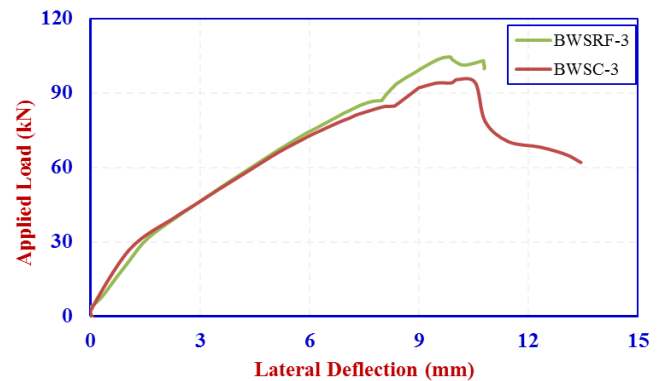
Fig. 15 shows the 30% shear reinforcement reduction specimens BWSC3 and BWSRF3. The BWSC3 specimen shows the load carrying capacity was 95.4 kN and its corresponding deflection was 11 mm. For BWSRF3 specimen, the ultimate load was 104.4 kN and its deflection was 9 mm. Therefore, retrofitted specimen shows significant strength than the conventional specimen.

Fig. 15: Load vs. Deflection curves for BWSC3 and BWSRF3.

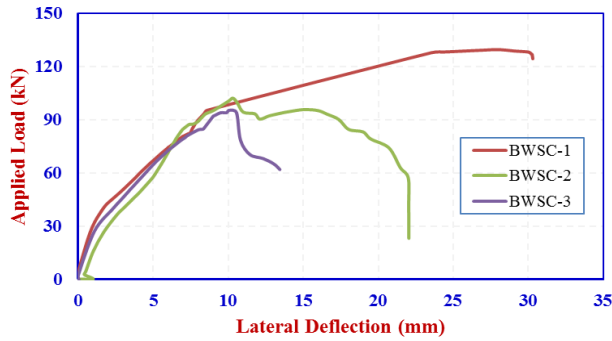
Fig. 16 shows the set-1 specimens BWSC1, BWSC2, and BWSC3. The BWSC1 showed significant load carrying capacity than specimens BWSC2 and BWSC3. The BWSC1 showed load carrying capacity of 129.6 kN which was higher than BWSC2 and BWSC3 shown loads of 102.2 kN and 95.4 kN respectively.

Fig. 16: Comparison of all Conventional specimens.

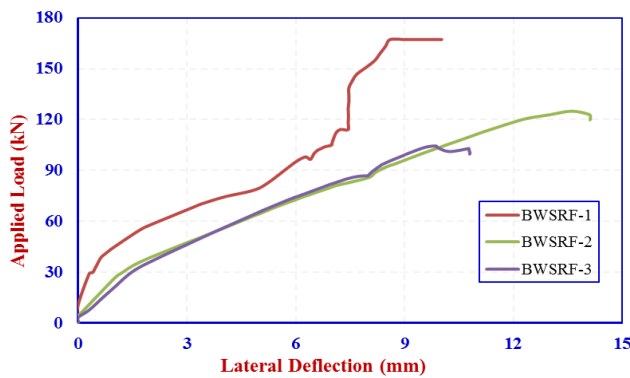
The Fig. 17 shows the set-2 specimens BWSRF1, BWSRF2 and BWSRF3. The BWSRF1 showed significant load carrying capacity than specimens BWSRF2 and BWSRF3. The BWSRF1 shown load carrying capacity of 167.24 kN which was higher than BWSRF2 and BWSRF3 having loads of 125 kN and 104.4 kN respectively.

Fig. 17: Comparison of all Retrofitted specimens

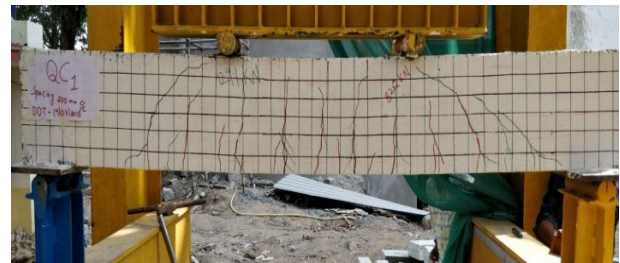
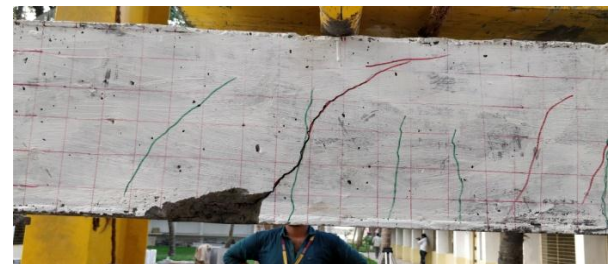
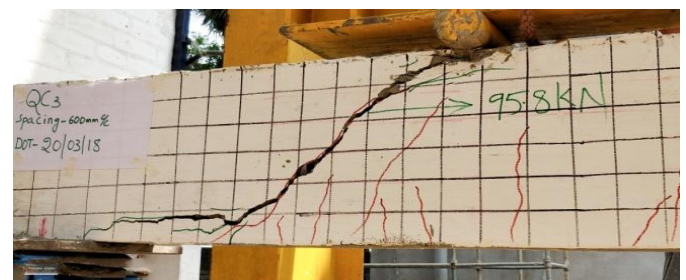
Fig. 18: Failure Mechanism for Conventional Specimens

Failure mechanism of all the set-1 and set-2 specimens is shown in Figs. 18 and 19 respectively. Majorly shear cracks were developed with various orientation angles for set-1 specimens whereas for set-2 specimens flexural cracks were occurred. The concrete gets crushed and bending occurs for shear reduction specimens because of more spacing of stirrups in set-1 specimens. Based to these shear cracks, the critical shear angle was observed in all set-1 specimens. Whereas for set-2 specimens, due to heavy stress, the GFRP strips resists the maximum loads coming on the beam. Due to strips, no cracks were encountered in the retrofitted area. Hence, retrofitted specimens with GFRP strips show significant strength and it is a very feasible solution for retrofitting the structure.

(a) Flexural and shear cracks in BWSC-1

(b) Crushing of concrete in BWSC-2

(c) Typical Shear crack occurs diagonally in BWSC-3

Beam Designation	Ultimate Load (kN)	Load at Initial Crack (kN)	Critical Shear Angle, θ (Degrees)	Mode of Failure
BWSC1	129.6	72	55	Flexure failure Shear failure
BWSC2	102.2	69	40	Shear failure + Crushing of concrete
BWSC3	95.4	70	52	Shear failure
BWSRF1	167.24	88.2	37	Flexure failure Shear failure

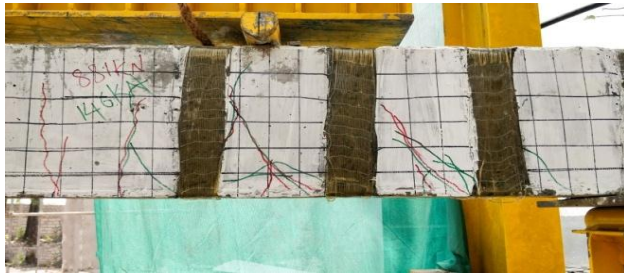
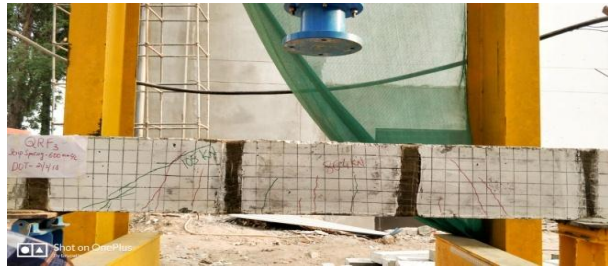
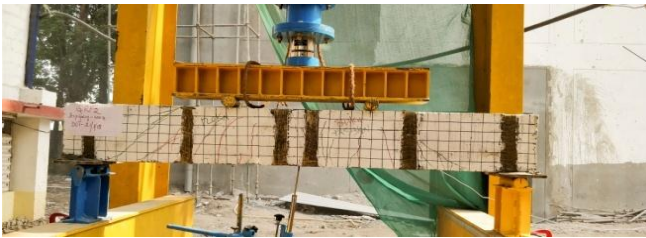
Fig. 19: Failure Mechanism for Retrofitted Specimens

(a) Flexural failure in BWSRF-1

(b) Shear failure in beam BWSRF-2

(c) Typically shear failure in BWSRF-3

BWSRF2	125	84.1	42	Shear failure
BWSRF3	104.4	85.2	22	Shear failure + Crushing of concrete

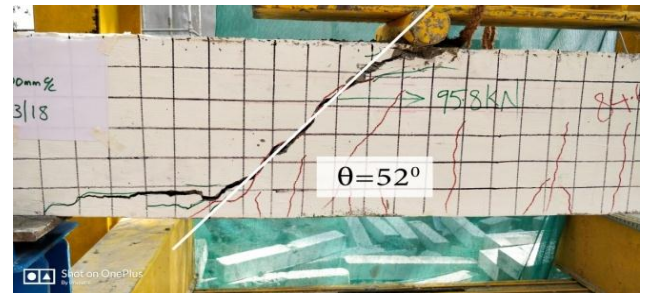
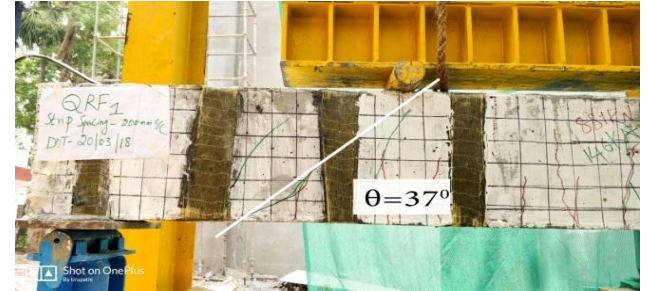
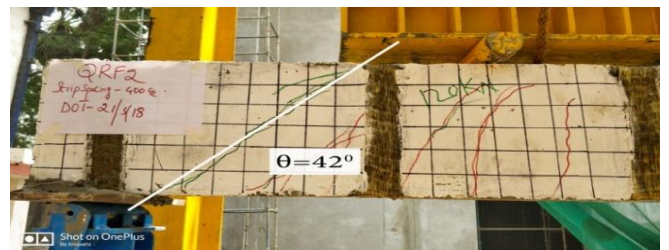
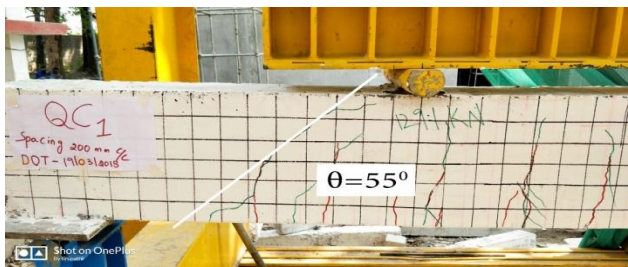
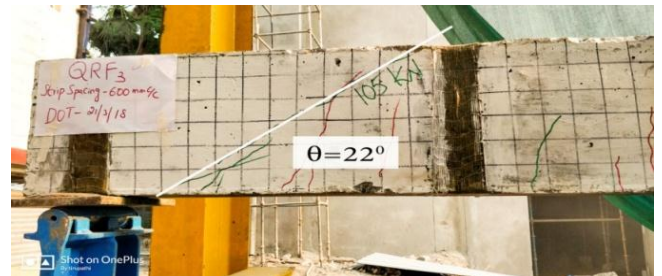
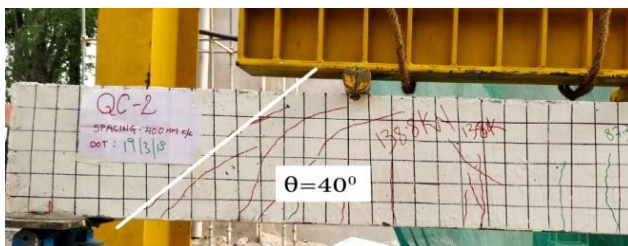
Fig. 20: Crack pattern for all specimens

(c) The crack pattern of BWSC-3

(d) The crack pattern of BWSRF-1

(e) The crack pattern of BWSRF-2

The crack pattern with their orientation angle for all the specimens is shown in Fig. 20. The crack pattern for conventional specimens lies within 40 to 55 degrees. While the crack pattern for retrofitted specimens lies within 20 to 45 degrees.

(a) The crack pattern of BWSC-1

(f) The crack pattern of BWSRF-3

(b) The crack pattern of BWSC-2

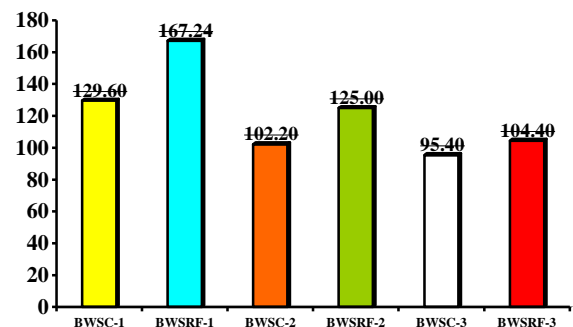
Fig. 21 shows the comparison of ultimate load carrying capacity of all the specimens. From Fig. 21, it was clearly noticed that BWSRF1 shown significant ultimate load carrying capacity. Comparing set-1 specimens with set-2 specimens, set-1 specimens have the more ultimate load carrying capacity i.e., BWSRF1, BWSRF2, and BWSRF3.
