# Experimental Comparability Among Different Accelerated Reinforced Steel Concrete Corrosion Methods

## Abstract

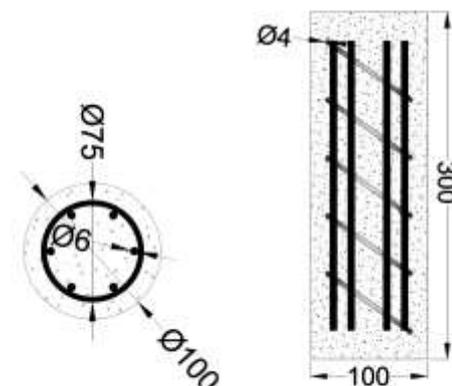
**Fig. 1:** details of the column in this study

A summarization was adopted to the properties of reinforced concrete fabrication materials were used in this investigation including cement, sand, gravel, and reinforcing bars. The cement used in production concrete was high sulfate resistance cement conforming to ASTM 150 [17] Type V cement as demonstrated in Tables 1 and Table 2 [18] as demonstrated in Tables 3 and Table 4 respectively. The adopted concrete mix proportion was designed according to ACI 211[19], the mix was 1:1.75: 3.5 (cement: sand: gravel) and the water to cement ratio equaled to 0.38. In addition, deformed steel bars with the nominal diameter of 6 mm were used for the main reinforcements and 4 mm plain steel bars were used as spiral stirrups. The reinforcement steel bars were compatible to ASTM A 615-15 [20]. All reinforced concrete columns were cured in tap water for 28 days. Figure 1 shows the column details.

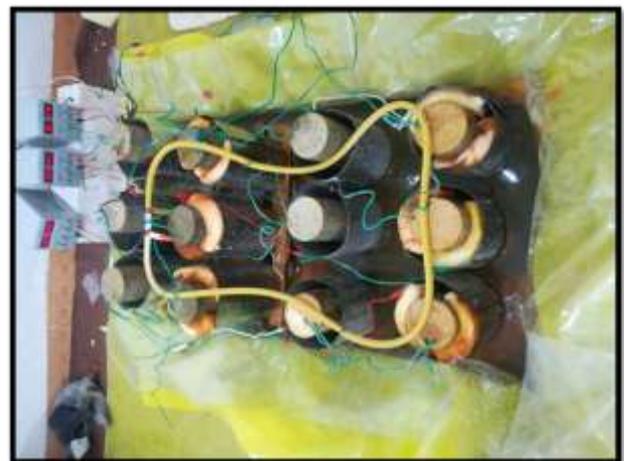
**Fig. 2:** the arrangement of the accelerated corrosion for all the specimens

Outside current methodologies have been successfully used to make quickened erosion in steel strengthening bars. Using outside electrical flows is extremely basic and includes making an electro-chemical circuit utilizing an outer power supply. The fortifying bars go about as an anode in the cell and an outside material goes about as the cathode [2]. Following 28 days of relieving, the strengthened solid sections were submerged in a 3.5% NaCl answer for 3 days, the test examples were shrouded in tempered steel work with wipe substance filling the hole between the fortifying examples and the work A consistent current was connected between the anode (strengthening steel bars in the example) and the cathode (outside hardened steel work) from a DC control source. The flows connected were 50, 200, 500  $\mu\text{A}/\text{cm}^2$ .

Every one of the segments examples exposed to interchange wetting and drying, nonetheless, half of segments examples incompletely submerged in saline arrangement around 33% of the aggregate tallness. Through the drying time frames, the current was killed and the examples were expelled from the wipe and presented to air in the lab for drying periods for the half examples, the rest of the examples the current ceaselessly connected in wetting and drying cycles. Table 5 outlines the data of the of quickened erosion process for all segments in this investigation. Figure 2 shows the arraignments of the quickening consumption process.

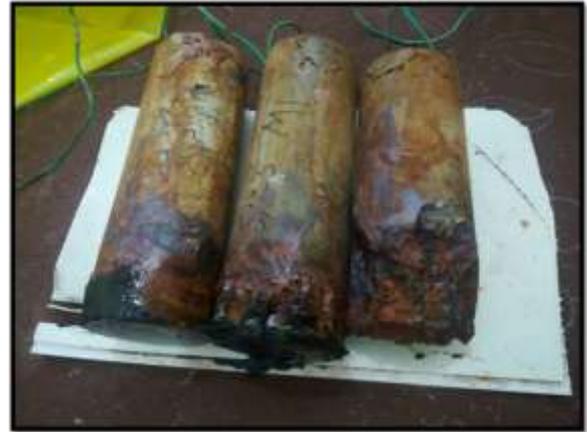
**Fig.3:** the damage shape in the partial immersion columns

The damage shape due to the growth of corrosion in the reinforcement steel bar was monitored for each column. Principally, two types of the damage shape were observed in most of the specimen. Figure 3 and Figure 4 display the different damage shape observed in this experimental study. The first type of damage shape in columns with wetting and drying cycles only (Col.2, Col.3, Col.5, and Col.6), most of the corroded columns had surface cracks in the side of column comparable to the main reinforcement steel bar was detected. Whereas, Col.2, Col.4 do not exhibit any surface damage after 20 and 12 wetting and drying cycles respectively (about 80 days).

The second type of the damage shape in partially immersed columns (Col.7, Col.8, Col.9, Col.10, Col.11, and Col.12) in which the cracks and the damage were identified in the lower parts of the columns that immersed in the saline solution. In spite of the severe damage in the lower part of the columns in this type of damage, the remaining part of the column still without any visual damage and cracks during the accelerated process.

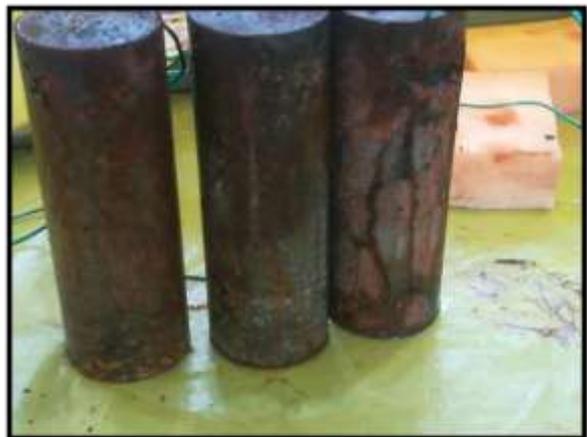
**Fig.4:** the damage shape in the wetting and drying only specimens.

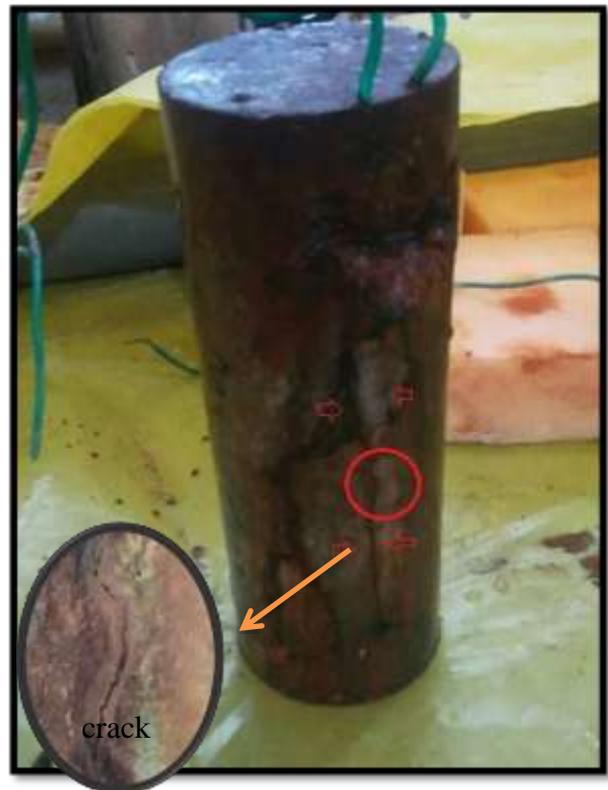
**Fig 5:** The cracking in the corroded column.

1-The dimension of current connected had no impact at first glance break design. For all test segments examples, the surface breaks because of quickened consumption of steel fortification were parallel to the fortifying bars randomly of the dimension of current connected to make the erosion of support.
