# Investigation of corrosion damage of hydration aluminium alloys at full-scale accelerated tests

The results of the study of hydrogen penetration in corrosion of aluminum alloys of eight alloying systems are presented. Tests were carried out for four years with additional irrigation with chloride solutions in a moderately warm climate. It is shown that intensive hydrogenation of the alloy occurs during corrosion. The amount of hydrogen in the alloy is determined by the type of corrosion - with intercrystalline corrosion, hydrogen penetration is more intense than with pitting and delaminating corrosion. The mechanism of hydrogenation of alloys is proposed. The change in the energy of the aluminum crystal in the occlusion of atomic hydrogen and the formation of hydrogen molecules is determined by quantum chemical calculations. The relationship between the plasticity of the tested alloys of aluminum alloys and the intensity of hydrogen saturation is shown.

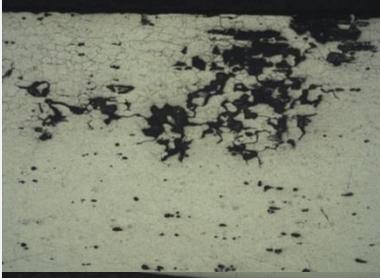
B-1341	Plate 1,5 mm	Al-0,7Mg-Si	0,000373 (4,19)

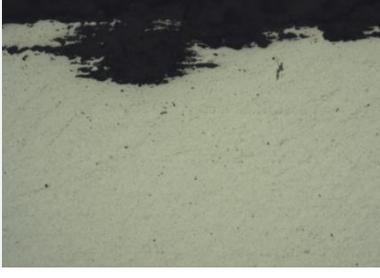
B-1461	Plate 2,0 mm	Al-2,8Cu-Li	0,000452 (5,08)

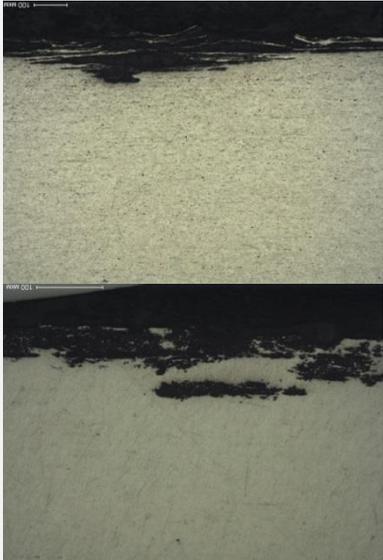
B96ц3пч	Plate 1,8 mm	Al-4,5Zn- 2,3Mg- 2Cu	0,000406 (4,56)
