# A Building Condition in Influencing the Walkable Environment in Traditional Street of Melaka Historical City

Nor Haslina Ja'afar<sup>1\*</sup>

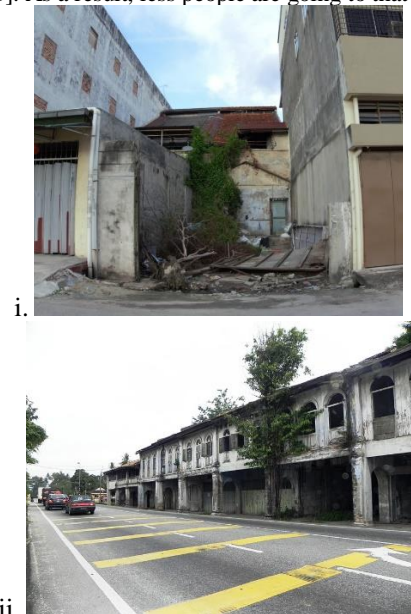
**Fig. 1:** (i) An example of demolished building in Kajang Town (ii) Pekan Kepayang

Another urban analysis study by UKM in Kajang Town and Pekan Nilai Lama Development showed that there are neglected heritage buildings. In the worst case scenario, some of the buildings had been demolished. The beauty and uniqueness of the townscape

spatial is eroding, thus disappearing the value of national heritage for future generations [12, 13]. However, a different scenario was encountered in Pekan Lama Kepayang, the oldest town in Lembah Kinta, Perak. Most of the building are abandoned thus becoming an idle town. The same fate with Pekan Lama Papan which is only inhabited by the elderly and many of the buildings are decaying over time [3]. As a result, less people are going to that place.

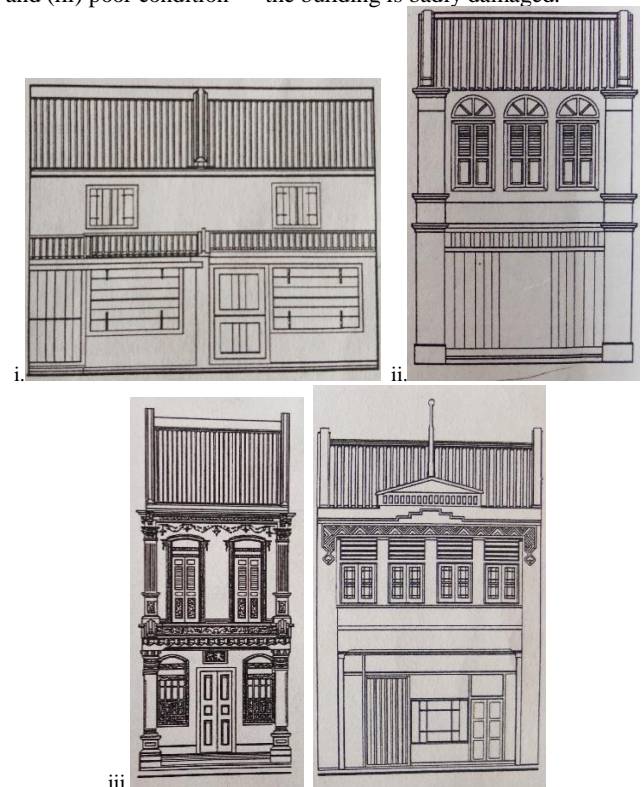
**Figure 2:** Typology of shophouses according to the older; (i) Early shophouses, (ii) 1st transitional shophouses, (iii) Late shophouses and European shophouses style [17]

Document review showed that all buildings have a very strong significant history where the oldest was built in the 1800s and the latest was built in 1960. These buildings were built under Dutch and British colonies with a diversity of style such as early shophouses (1800s), first transitional shophouses, late shophouses style (1900–1940s), European shophouses style (1930–1960s) (Figure 2) [17]

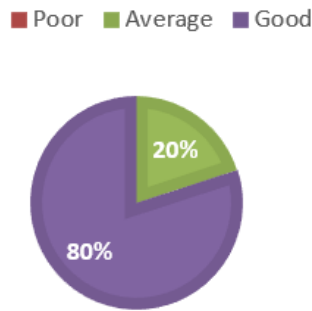
Fig. 3: A pie chart: Building condition from visual survey

However in our visual survey, majority of the buildings are in good condition (80% - 132 units) and the remaining 20% (33 units) are in average condition (Figures 3 and 4). During the visual survey, several buildings were under conservation construction in order to upgrade the condition. This shows that the preservation of our historical significant building is essential which is associated with the building's condition.

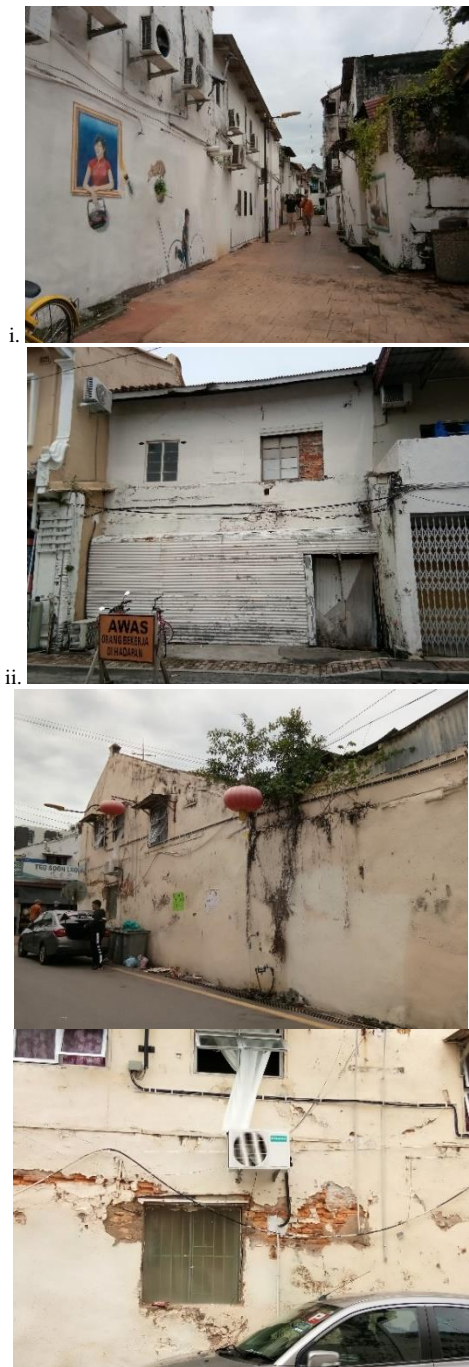
Fig. 4: Buildings with (i) a good condition of building enhances the uniqueness and quality of view of the place, thus encouraging a pleasant and walkable environment and (ii) an example of average condition of building condition
