Failure Analysis of Weld Metal Cracking in Weld Joint of API 5L X 75 Pipelines Steel

¹Abbas Kamil ALrubaeiy¹M.Sc. Metallurgy Engineering
Missan University

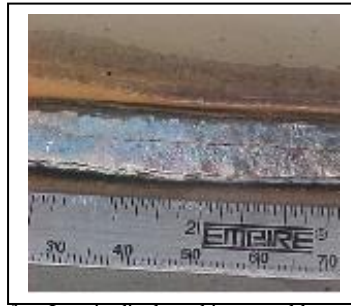
Fig.5: Surface Longitudinal cracking at weld metal region

Visual examination of the failed sample indicated longitudinal cracking was evident at weld metal region. There was no evidence of branching in the primary crack as shown in Fig. (5).

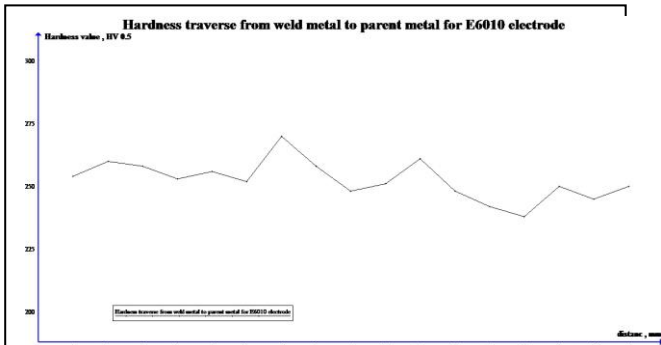
Fig. 10: Hardness traverse from weld metal to parent metal for E6010 electrode

The results of Vickers micro-hardness tests carried out at different regions of the weld metal cross-section sample at preheat temperature of 22°C and 35°C as shown in Fig. (10).The hardness of the HAZ near the fusion boundary towards the weld metal was found to be higher than for the base metal and weld metal. Also base metal hardness values generally exceeded that of the weld metal. From the results, it is evident that the under matching electrode has produced a

softer and coarser microstructure than the base metal. Average weld metal hardness is given in table (3).The hardness values for weld metal at different preheat temperature do not show any systematic trend and therefore hardness values cannot be taken as a predictive tool to determine the likelihood of crack in the weld metal.
