International Journal of Advanced Geosciences, 8 (2) (2020) 237-243

Geoelectrical and geotechnical investigation of foundation failure in and around Oroke high school, Akungba-Akoko, southwestern Nigeria

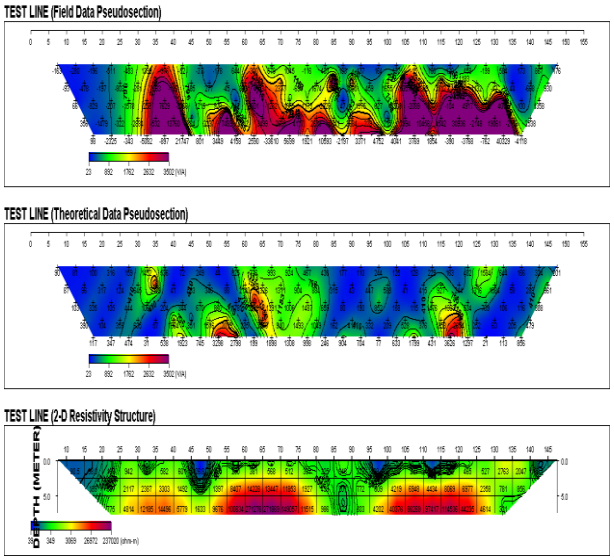
The calculated apparent resistivity values of the acquired field data were used to generate the pseudo-sections that is illustrated in Figure 5. The sections give the details of the lateral and vertical variations in ground apparent resistivity beneath each specific traverse line as opposed to the profile 1 that entailed 2–D vertical probing of the subsurface. The surface resistivity response beneath the T1 profile can be divided into three patterns.
The first pattern has a continuous low resistivity response with resistivity in the range of 27 – 139 ohms-m. Its distribution is not continuous but appear in localized regions as pockets of resistivity material between stations 0 and 20, 45 and 50 and 140 m to the end of the traverse. The second layer delineated is the partly weathered layer/ fractured layer (green pseudo - section) with resistivity value ranging between 200 and 700ohms-m. This pattern is extensive and occur as the first pattern in some places along the profile where the localized pockets of low resistivity materials are absent. The third pattern is the fresh Basement (Yellow / Red coloration) having very high resistivity that

approach infinity. On the pseudo section, there is an observable Basement depression between stations 45 and 50 m. There is also a prominent fracture between station 80 and 100 m. The Basement appears to be shallow in the region, occurring at the depth of approximately 3 m.

Fig. 5: Composite Plot of Pseudo- Section of Result of 2D Resistivity Inversion Beneath 1(A) Observed Resistivity Data, (B) Computed Resistivity Distribution and (C) Inverted Resistivity Structure.

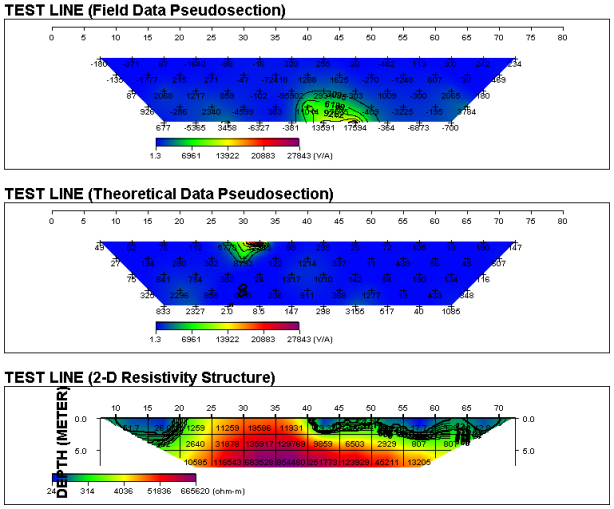
The calculated apparent resistivity values of the acquired field data were also used to generate the pseudo-sections that are illustrated in Figure 6. The sections give the details of the lateral and vertical variations in ground apparent resistivity beneath each specific traverse line as opposed to the profile 2 that entailed 2–D vertical probing of the subsurface. The surface resistivity response beneath the T2 profile can be divided into three patterns. The first pattern is continuous low resistivity response with resistivity in the range of 24 – 64 ohms-m. Its distribution is not continuous but appear in localized regions as pockets of resistivity material between station 0 and 20, 40 and 50 and 70 m to the end of the transverse. The second layer delineated is the partly weathered layer/ fractured layer (green pseudo - section) with resistivity values ranging between 225 and 942 ohms-m. This pattern is extensive and occurs as the first pattern in some places along the profile were the localized pocket of low resistivity materials are absent. The third pattern is the fresh Basement (Yellow / Red colouration) having very high resistivity that approach infinity. On the pseudo section, there is an observable Basement depression between stations 55 and 60m. There is also a prominent fracture between stations 62 and 65 m. The Basement appears to be shallow in the region, occurring at the depth of approximately 2 m.

Fig. 6: Composite Plot of Pseudo- Section of Result of 2D Resistivity Inversion Beneath 2 (A) Observed Resistivity Data, (B) Computed Resistivity Distribution and (C) Inverted Resistivity Structure Dipole – Dipole Pseudo-Sections Along Traverse TR3.

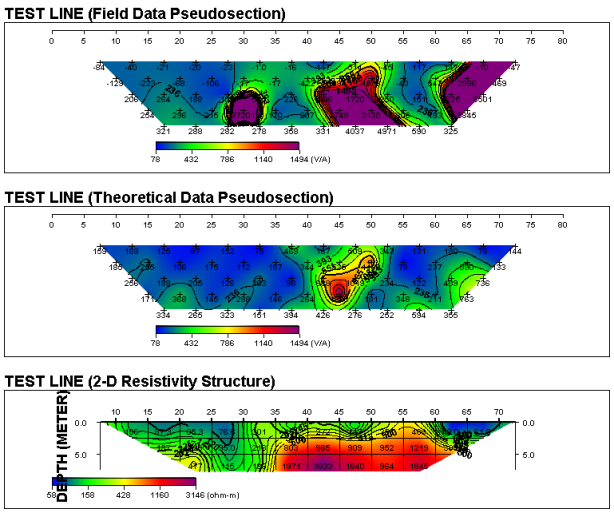
The sections in figure 7 give the details of the lateral and vertical variations in ground apparent resistivity beneath each specific traverse line as opposed to the profile 3 that entailed 2–D vertical probing of the subsurface. The first pattern has a continuous low resistivity response with resistivity in the range of 36 – 64 ohm-m. Its distribution is not continuous but appear in localized regions as pockets of resistivity material between station 0 and 36, 50 and 63 m respectively to the end of the transverse. The second layer delineated is the partly weathered layer/ fractured layer (green pseudo - section) with resistivity value ranging between 489 – 1219 ohm-m. This pattern is extensive and occurs as the first pattern in some places along the profile were the localized pocket of low resistivity materials are absent. The third pattern is the fresh Basement (Yellow / Red colouration) having very high resistivity that approach infinity. On the pseudo section, there is an observable Basement depression between station 60 and 70 m. There is also a prominent fracture between stations 27 and 35 m. The Basement appears to be shallow in the region, occurring at the depth of approximately 2.5 m.

Fig. 7: Composite Plot of Pseudo- Section of Result of 2D Resistivity Inversion Beneath 3(A) Observed Resistivity Data, (B) Computed Resistivity Distribution and (C) Inverted Resistivity Structure.
