International Journal of Engineering & Technology, 7 (3.18) (2018) 83-86

Corrosion Study of Galvanized Ultra High Strength Steel Reinforced Overhead Transmission Conductors

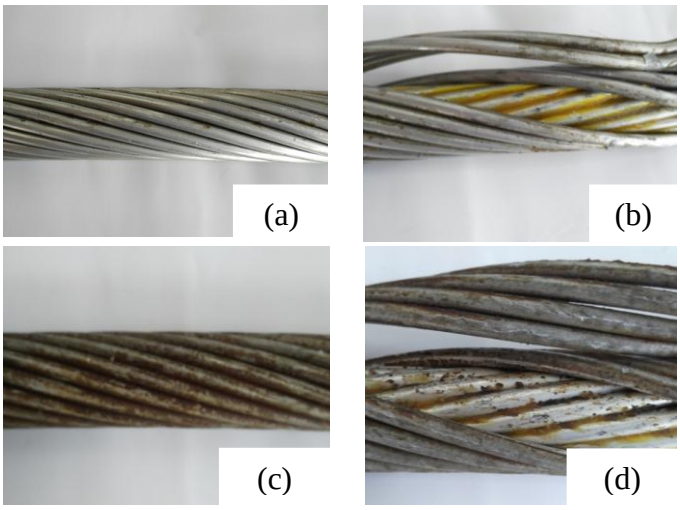
The as received wires were cut into specimens of about 9 inches and cleaned from dirt and grease. On first visual inspection the grease on used conductors was much dry and black in color. Figure 2 shows the picture of inner structure as observed through naked eye.

Figure 2: Outer construction of the ACSR conductor (unused (a) and used (c)). Aluminum strands are in spiral form. (b) and (d) show the status of inner layers. Degradation in the grease quality is obvious.

Upon visual inspection the grease on the outer layer for used conductor is relatively dry and dark spots are visible compared to the unused one. Further observation of the interior layer reveals that the grease exists but its quantity is less than the grease inside unused conductor. This is understandable as temperature changes and weather effect tends to degrade and contaminate the grease.

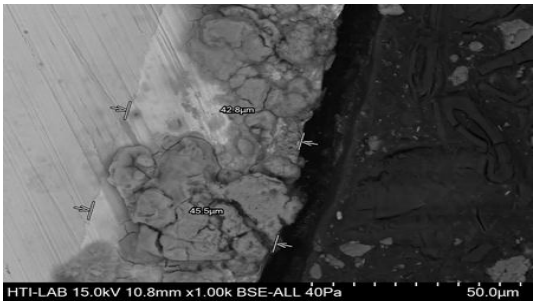
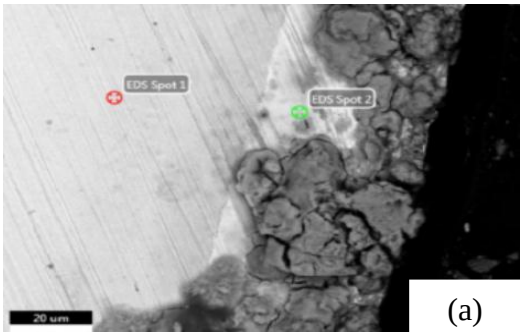
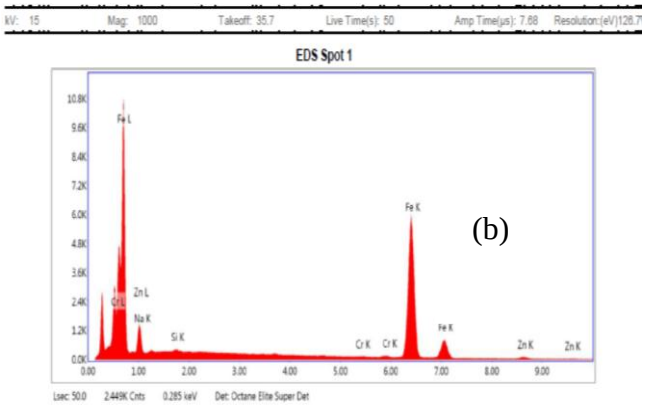
Figure 3 below presents an SEM image of polished steel strand from the ACSR330 conductor. This shows the state of zinc coating produced through galvanization on an unused conductor. The image has been taken by FE-SEM where the electron beam is produced through schottky effect Field Emission Gun. Such samples are very difficult to polish as the steel substrate is very strong and hard whereas the zinc coating is very soft. In order to obtain uniform polishing on both surfaces, it is very difficult to conduct polishing for a longer time, in detriment of polishing debris. The section is polished after mounting on a resin base. The resin debris can be seen accumulated on the coating edge due to its detachment from the mount. The image demonstrates a clean and smooth coating-steel interface, and the coating thickness is more or less uniform. The coating thickness varies between 42 to 45 µm.

Figure 3: SEM image of polished surface of unused steel wire cross section.

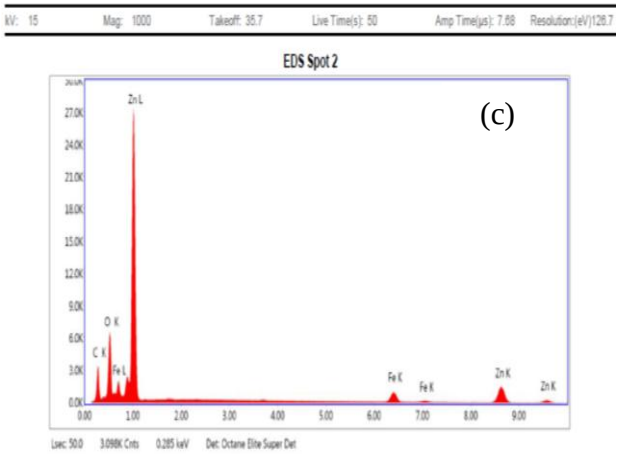
Figures 4 (a), (b) and (c) show the spot EDAX analysis on the same image with precise spot position as indicated. It can be seen that the spot 1 is mainly composed of Fe with traces of chromium, carbon, Na and Zn (Figure 4 (b)). The presence of Zn at this spot can only be explained by the fact that during polishing, soft particles of zinc can detach and get deposited onto the steel surface. In Figure 4 (c) it is evident that the spot 2 is mainly composed of pure zinc.

Figure 4: (a) SEM image of the polished surface of unused Steel wire cross section indicating the two spots of EDAX (b) Elemental spectra for spot 1 produced through EDAX (c) Elemental spectra for spot 2 produced through EDAX

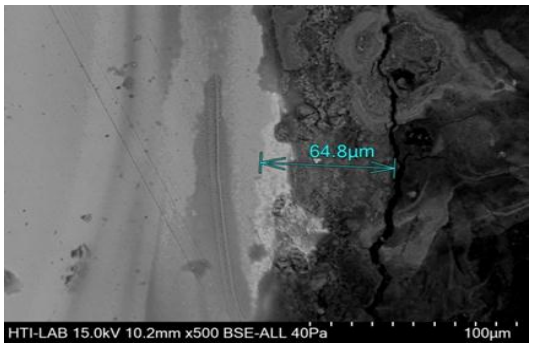
Figure 5 reveals a very interesting micro structure. This is the SEM micrograph of the same galvanized steel strand but which has been in service for about 30 years. The high temperatures produced through thermal effect of high voltage and current combined with the time effect resulted in diffusion and counter diffusion of zinc coating into the steel conductor and diffusion of elements within steel into the zinc coating. The interface can be seen highly distorted and highly diffused, the coating thickness has changed, strikingly, the thickness has increased. This increase in thickness resulted in the dilution of zinc inside the coating.

Figure 5: SEM image of the polished surface of used steel wire cross section.

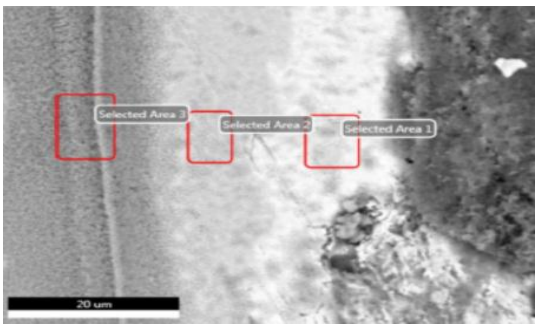
Figure 6 presents the same polished surface under higher magnification and three areas are selected for Elemental analysis, Area 1, Area 2 and Area 3, represented by the red color rectangles. Area 1 is well inside the coating, Area 2 is between the coating and the substrate, whereas the area 3 is within the Steel substrate. The EDS results are shown under Figure 7 (a), (b) and (c). the Figure 7 demonstrates clearly that under the action of time, heat and cyclic stresses, the zinc has diffused into the steel. The coating thickness has now increased to about 65 microns at first sight, but actually, the zinc presence can be detected at a much longer distance into the steel core. The EDAX area scans give evidence that significant quantity of Zn has diffused into a distance of up to 130 µm into the steel boundary. Meanwhile Fe is also detected within Zn coating. This is a phenomenon produced as a result of counter diffusion of the two species, Fe and Zn.

Figure 6: SEM image of the polished surface of used Steel wire cross section indicating the three selected areas for EDAX

One very interesting feature observed in Figures 6 and 7, where the diffusion of Zn appears to create bands of concentration in which the concentration of Zn appears to increase and decrease in a wave like fashion. A very similar phenomena is observed in mineral deposits, which occurs over a much longer period of time, named *Liesegang* bands after the famous scientist who discovered it in 1896. Several researchers have studied this phenomenon in minerals (Kulkarni S.D. *et al*, 2017, Rajurkar N. *et al*, 2015, George J. *et al*, 2005 and George J. *et al*, 2003) but in metals this phenomenon has not been studied so far.

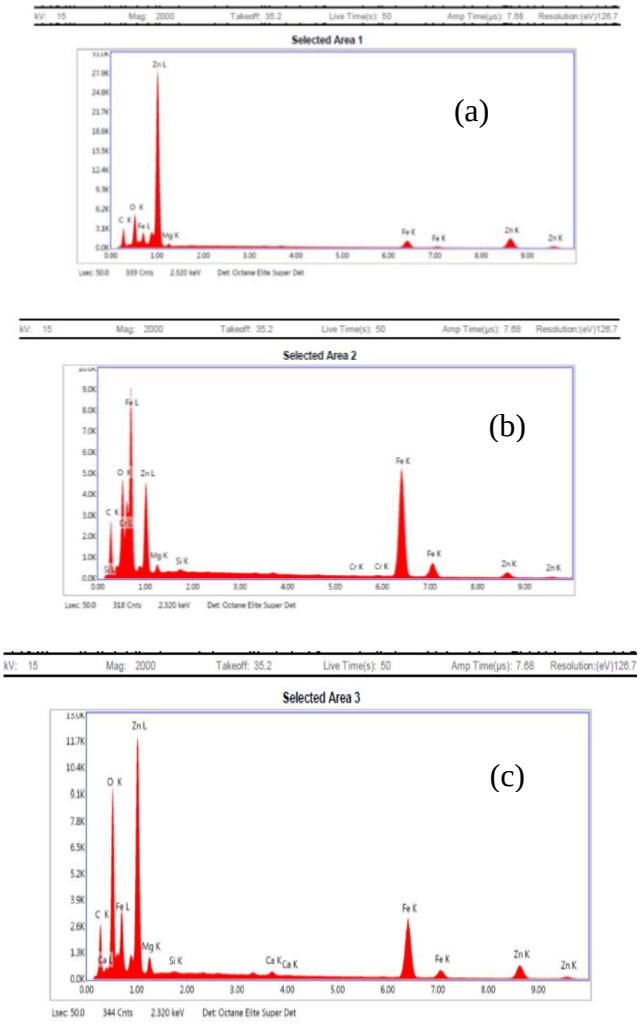
Figure 7: (a) Elemental spectra for Selected Area 1 produced through EDAX (b) Elemental spectra for Selected Area 2 produced through EDAX (c) Elemental spectra for Selected Area 3 produced through EDAX.

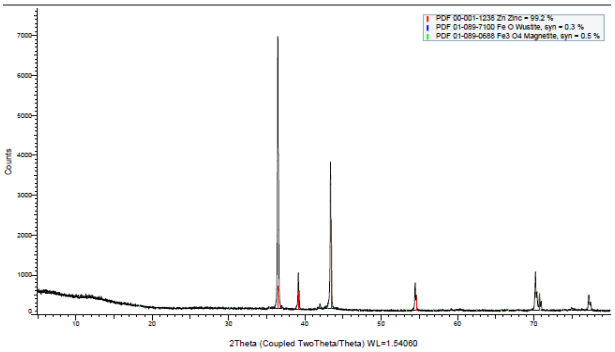
Figure 8 shows that the surface coating on unused ACSR conductor steel wire contains 99.2% zinc. The zinc coating in this sample is almost unaffected as also demonstrated in EDAX results (Figures 4 (a), (b) and (c)). The total oxide content is less than 0.5%, which can be considered as negligible. On Figure 9 the XRD spectrum of used Steel wire surface is presented. In this figure the zinc content on the surface of the coating drops from 99.2 to 90%. There is presence Chromium Carbide (8.5%) which is believed to have diffused out of the steel core (Counter diffusion with Zn). This confirms the initial finding through FESEM and EDAX (Figures 7 (a), (b) and (c)) that Zn has migrated into the steel core and elements from steel have counter diffused towards outside surface. This has happened over a long period of 30 years of heating and cooling within acceptable temperatures. The total oxide found on the strand surface is less than 1%.

Figure 8: XRD patterns of the galvanized surface of unused steel wires from ACSR330 conductor.

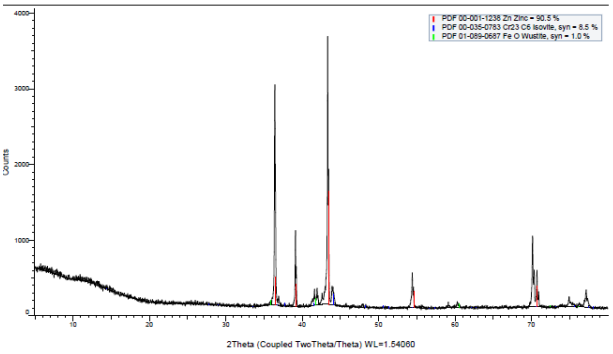
Figure 9: XRD patterns of the galvanized surface of used steel wires from ACSR330 conductor.
