Assessment of the Structure Failure of the Palm Oil Mill Effluent (POME) Digestion Tank Constructed on Peat Soil

Khairullah Yusuf[1]*, Shahlin Sulaiman[2], Shan Suleiman[2]

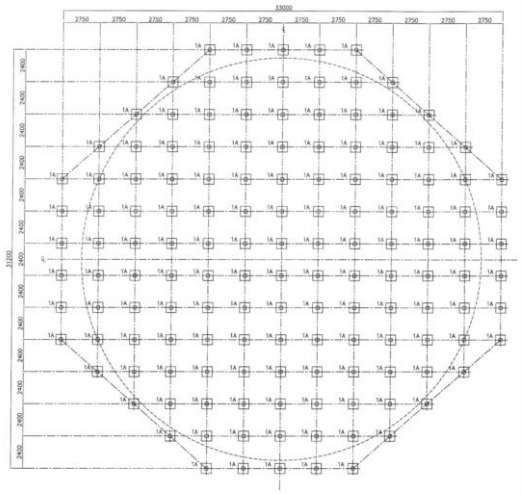
Fig. 1: Layout of piles of the digestion POME tank

There are 142 piles were used as the foundation and also as the column for the tank which was driven to the depth between 45 m to 48 m in average. Generally, the piles cannot be driven absolutely vertical and true to position. In other words, generally, the driven piles on peat soil most probably will be deviated and inclined from its intended position. Even in ideal conditions, the centre of a pile head must be allowed to deviate a certain amount from the required location [4]. In addition, the stress mechanism of inclined piles is very complicated with influences resulting from the vertical load, horizontal load or inclined load simultaneously [5]. Furthermore, based on the pile parameters as in Table 1, the relationship of axial load and moment capacity of the pile is graphically shown in Figure 2.

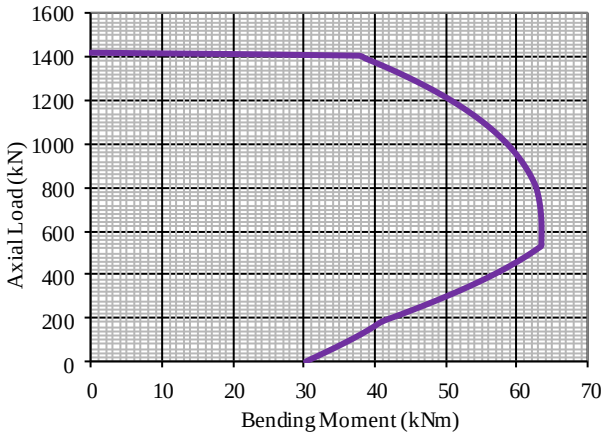
Fig. 2: The relationship of axial load and moment capacity of the pile

The further analysis was done with various loading on each pile for Tank No. 2 which are 100 % loading, 66.67 % loading, 50 % loading, 20 % loading and 0% loading (only dead load – load on tank empty + structure weight) were calculated and the resulted imposed moment on each pile were analysed. The piles were then checked for their allowable moment at the loading based on the graph axial load vs moment capacity as in Figure 2 above.

To establish the failure/collapse mechanism, the induced moment and induced axial on the piles due to the different loading of the POME digestion Tank No. 2 were checked against the allowable moment capacity and bearing capacity of the individual pile at the existing state. Harries [8] stated that moment capacity at the pile-to-pile cap interface is determined from the moment capacity of the pile. The result of this analysis is presented in Table 2. The typical plotting of induced axial load and moment on each pile on the diagram of axial-bending moment capacity of the piles at 100% loading is presented in Figure 6.

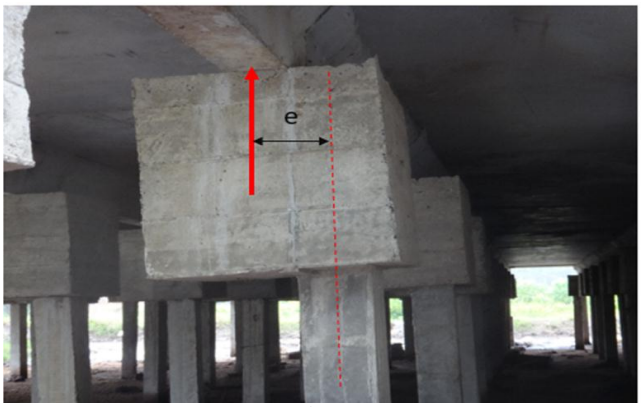
Fig. 3: Pile deviated from its intended position

Furthermore, the piles were designed to directly support the beams and in turn support the RC platform where the POME tanks are resting. However, at the site most of these piles have deviated/offset from their intended position as shown in Figure 3. To transfer the load from the beams to the deviated piles, pile caps were constructed that extend from the piles up to the intended pile positions. In doing so the pile caps also act as a cantilever beam. This arrangement of pile caps has induced moment on to the piles. Generally, in the design, allowance should be made to cater bending stresses due to eccentric or lateral loading and to eccentricity caused by deviations in the straightness and inclination of a pile [7].

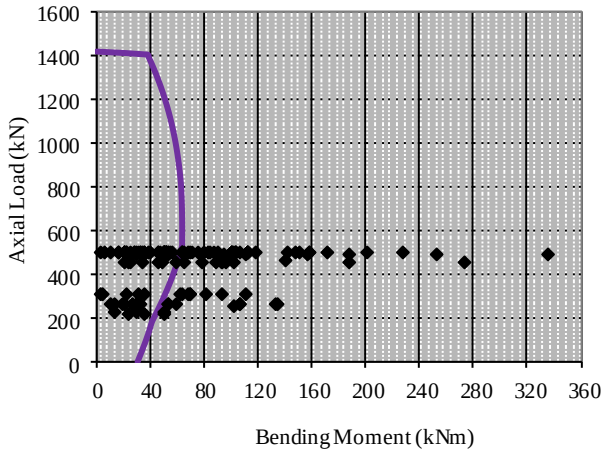
Fig. 6: Plotting of induced axial load and moment on each pile on diagram of axial-bending moment capacity of the piles Tank No. 2 at 100% loading.

Based on the above, it seems that at 100 % loading the piles of Tank No. 1 and Tank No. 2, would most likely fail due to induced moments that exceeded allowable moment capacity of the piles and induced axial loads exceeded bearing capacity of the piles.

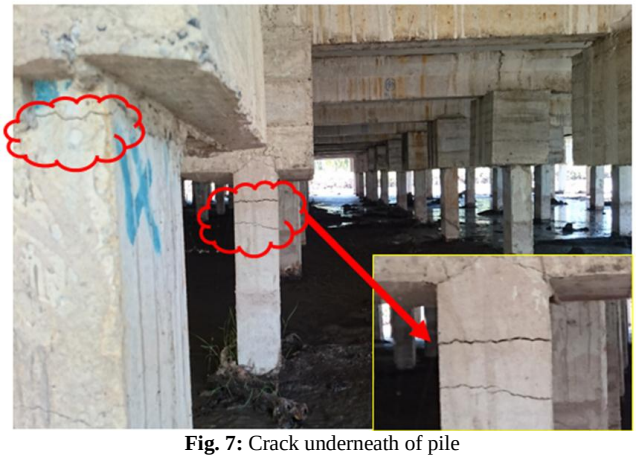
Fig. 7: Crack underneath of pile

The crack found on certain piles just beneath their pile cap as shown in Figure 7 affirmed the failure due to the moment.
