International Journal of Engineering & Technology, 7 (4.5) (2018) 341-346

Evaluation of Lacquered Tinplate Corrosion in Canned Food through Characterization by using SEM & EDS Technique

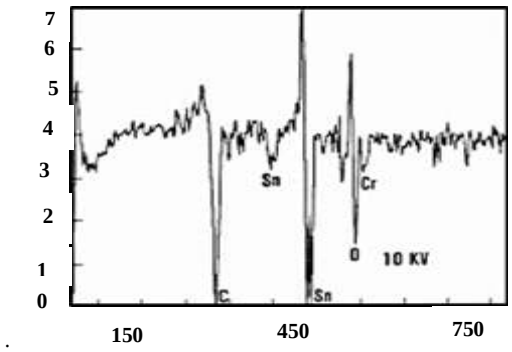
Figure 5: Presence of carbon in cleaved area

- Figure 5 & 6 shown the Auger spectrum, no. of electrons vs Electron Kinetic energy which was obtained by the above sample examination with AES. The obtained spectrum indicated the presence of an abnormal amount of carbon in the pores of cleaved areas of tin-coating. Whereas no carbon was detected in the adjacent to the cleaved area of tin.

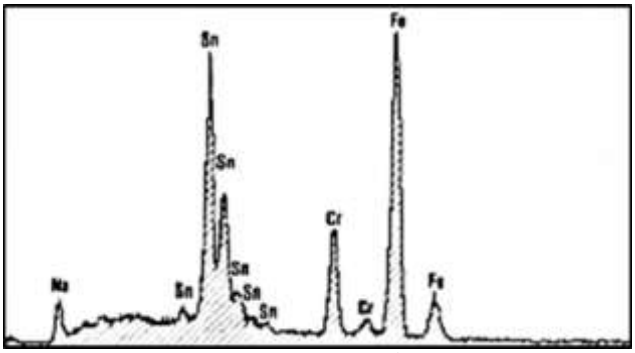
Figure 10: Energy Dispersive X-ray analysis of Particle, indicating Presence of Sodium di-chromate

It was also noticed during SEM examination that there were many small particles around the perimeter of the eyehole. To know the particle nature, it was anlaysed through EDS, which gave indication that the particle contained sodium and chromium which was most probably originated from sodium dichromate treatment solution in tinning line. X-ray spectrum generated by EDS analysis from the entire scan area of SEM shown in figure 10.

- Figure 10 shows the X-ray spectrum generated by EDS analysis from the entire scan area of SEM. During observation at higher magnification many small particles around the perimeter of the eyehole were observed. To know the particle nature, it was anlaysed through EDS, which gave indication that the particle contained sodium and chromium which was most probably originated from sodium dichromate treatment solution in tinning line.
