International Journal of Engineering & Technology, 7 (4) (2018) 4528-4533

Environmental carrying capacity review in cengklik reservoir

Runi Asmaranto [1] *, Antonius Suryono [2]

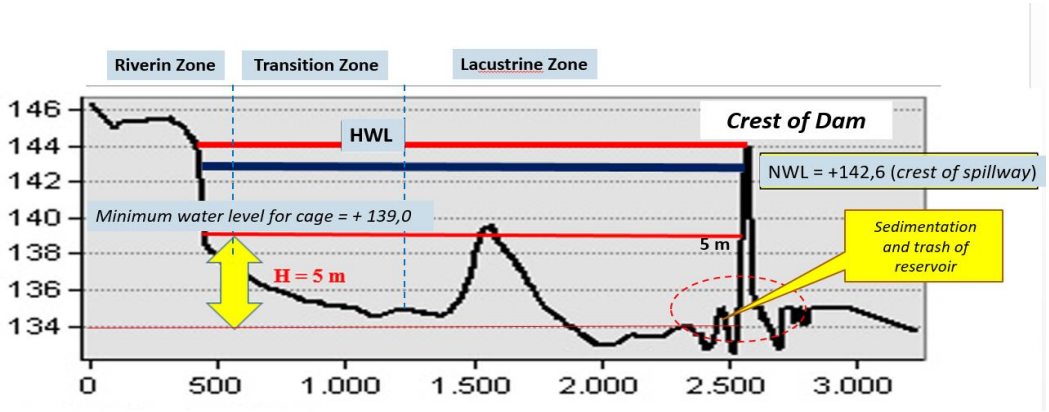
Fig. 3: Reservoir Zonation and Minimum Elevation of Floating Net Cages/ KJA Cultivation.

The amount of fish production and the amount of feed consumption in the Cengklik Reservoir turned out exceeding the carrying capacity of the Floating Net Cages/ KJA aquaculture with both alternatives. The use of fish feed 673.2 tons of feed/year far exceeds the feed carrying capacity/ daya dukung pakan (DDPk) 490.64 tons of feed/year for alternative 1 (Elevation of Reservoir Water Level in normal condition NWL = + 142,6), and 470,3 of feed/year for alternative 2 (minimum water level of cages + 138,6) and 367,68 tons of feed/year for alternative 3 (water discharge conditions in dry years). The number of KJA plots currently also exceeds the carrying capacity of the Floating Net Cages (DDKJA) which should be 770,37 plots (alternative 1), 752,13 plots (alternative 2), and 577, 30 (alternative 3) but in reality in 2016 the number of plots was 1057 with the number of fishermen as cage owners around 136 people. From the results of the interview on the excellent condition the fishermen in Cengklik Reservoir can harvest fish about 1 ton per fisherman (average 12 cages boxes) for one harvest season. But in bad conditions, it can only harvest about 2 quintals of fish. Meanwhile, according to Mr Maryanto (Head of KJA Ngargorejo which has 10 cages) can harvest about 6 quintals/month in good condition while the worst is about 3 quintals/month [12].

5) The number of Floating Net Cages/ KJA and consumption of fish feed in the Cengklik Reservoir has exceeded the allocation of waste load and reservoir carrying capacity, so the amount must be reduced by a maximum of 770 plots at normal water level conditions (+142,6) while at a low elevation (+ 139.00) a maximum of 577 plots, as well as the location/position settings.

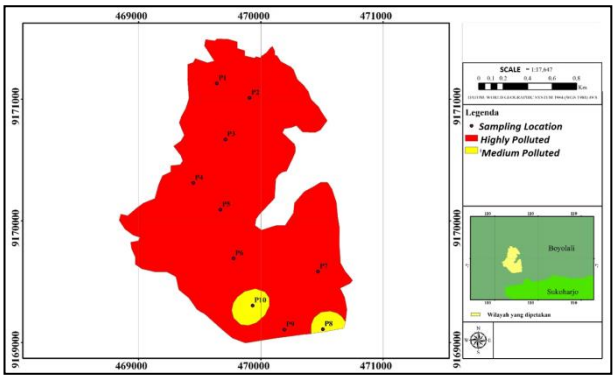
Fig. 4: Zonation Map of Pollution Index Class 1.

Based on the analysis results in Table 4 below, it can be seen that the condition of the cengklik reservoir has been in the category of highly and medium polluted for water quality class I and class II, it means that the surface water condition of Cengklik Reservoir is not feasible for the consumption of raw water or drinking water, because there are some pollution weighing factors such as BOD, COD, TSS, Total Coliform, Fat Oil content, Lead/ Pb content, Manganese, Sulfide, Nitrite and Phospat, all parameters above the threshold of class I and class II. Even from data analysis of 2014, 2015 and 2016, water quality based on Class I quality status is highly polluted between 75 - 95%, the remain is medium polluted status and no lightly polluted status for Class I. Whereas for Class II Status, the Highly Polluted Status between 50 - 60% and the rest is medium polluted. Meanwhile based on Class IV status there is a fulfilled category (point P10 near main dam), lightly polluted, medium polluted and highly polluted (point P6 in the middle of the reservoir).

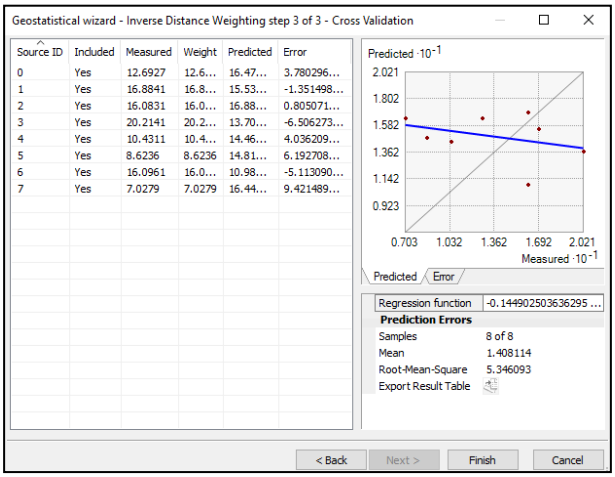
Fig. 6: Geostatistical Analysis on Pollution Index-Class I.

Num	Parameter	Mean	RMS value
1	Pollution Index Class I	1,4081	5,3461
2	Pollution Index Class II	1,2198	4,0325
3	Pollution Index Class III	1,1862	3,8468
4	Pollution Index Class IV	2,5218	4,9788
