International Journal of Engineering & Technology, 7 (4.35) (2018) 172-176

Slope Stability Analysis of Granitic Residual Soil Using SLOPE/W, Resistivity and Seismic

RC Omar[1]*, INZ Baharuddin[2], Hairin Taha[3], R.Roslan[4], Hazwani NK[5], Muzad MF[6]

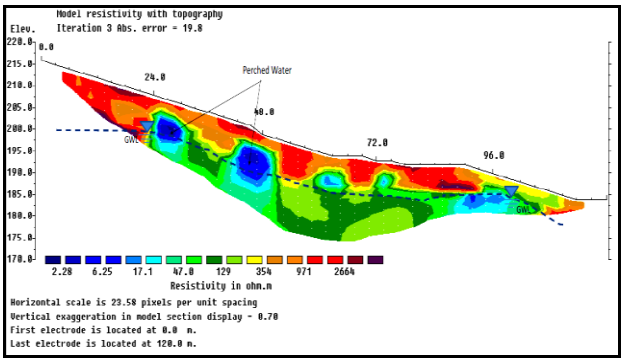
Fig.3: 2D Resistivity model of study area

Based on the resistivity survey, the existence of groundwater level has been found at a depth of 10.0 m from ground level. Generally, the subsurface is made up of sandy soil from weathered granite which range of resistivity value from 351 Ohm-m to 2670 Ohm-m. The stiff to very stiff layers of Sandy CLAY were interpreted 10.0 m below the surface around the tower with range of resistivity value 41 Ohm-m to 130 Ohm-m.

The Standard Penetration Test (SPT-N) and Rock Quality Designation (RQD) for soil and rock types in Table 3 have been interpreted at 1.5 m depth from the surface level based on the depth of borehole. This area consists entirely of weathered rock with RQD values of 25% to 50%, only a quarter of the area with RQD values of 50% to 75%. The stiff to very stiff soils were discovered at 10.0 m depth with SPT-N values 9 to 26.

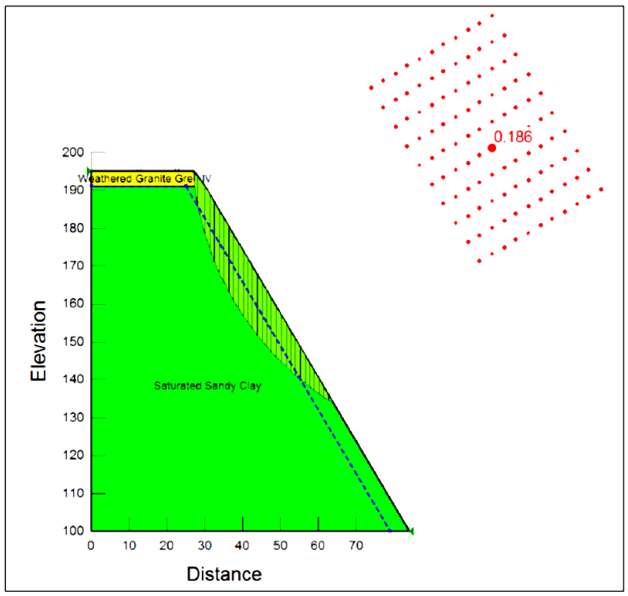
Fig.4: FOS model of study area.

SLOPE/W analysis was processed based on geophysics analysis; resistivity and seismic as well as laboratory testing. From this analysis, the slope was predicted to be unstable based on FOS value which was 0.186 according to the guideline of slope stability. Table 6 shows the parameters of SLOPE/W analysis that generates FOS as shown in Figure 4.

From the geophysics analysis, Weathered Granite Grade V with RQD values of 25% to 50% was detected at the surface of the slope. The Sandy CLAY that has SPT-N values from 1 to 26 was discovered at 5.0 m to 10.0 m depth. Factor of safety for the slope was 0.186 which is less than 1.0 indicating the instability of the slope condition. The actual slope circle failure has already taken place at the study site and the soil nailing was installed to prevent further slope failure. The study area was also experiencing soil erosion on the surface due to the existence of small gully that has developed previously. Following these observations, erosion control measures should be carried out to prevent or reduce movement of eroded soil sediments off-site or land. The controls often involve the creation of a physical barrier, such as vegetation cover or rock, to absorb some of the energy of water that is causing the erosion.

Constant monitoring should be carried out on existing slope to prevent the recurrence of slope failures. Field monitoring provides the information and new insights on the condition of the slope [18]. The existence of groundwater level has been found at a depth of 10.0 m from ground level. During rainfall, the possible increase of groundwater level can reduce the strength of soil, thus this can affect the stability of the slope [19]. In previous cases of slope failures, a very high water table was identified as the most common cause of slope failure.

The stability of a soil-nailed system throughout its design life needs to be assessed. Its performance should not exceed a state at which failure mechanisms can form in the ground or within the soil-nailed system, or when movement of the soil-nailed system can lead to severe damage to its structural elements or nearby structures and facilities. For this area, the design of a soil-nailed system should be ensured that there is an adequate safety margin against all the perceived potential modes of failure. The environmental conditions should be investigated at the design stage to assess their significance in relation to the durability of soil nails. Appropriate measures should be applied to the soil nails such that an adequate safety margin of the soil-nailed system can be maintained throughout its design life. Doing so, the risk of slope failure in the study area can be minimized.
