International Journal of Engineering & Technology, 7 (3.28) (2018) 244-251

Association between Lineaments and Groundwater Intrusion into Tunnel Built in Granitic Rock Mass

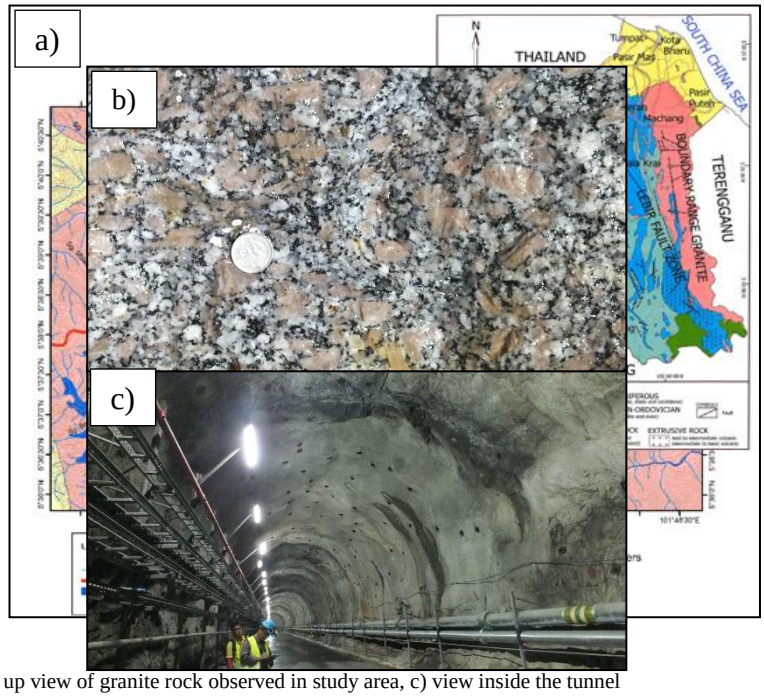
Fig. 1: The figure shows a) Geological map of study area [16], b) close up view of granite rock observed in study area, c) view inside the tunnel

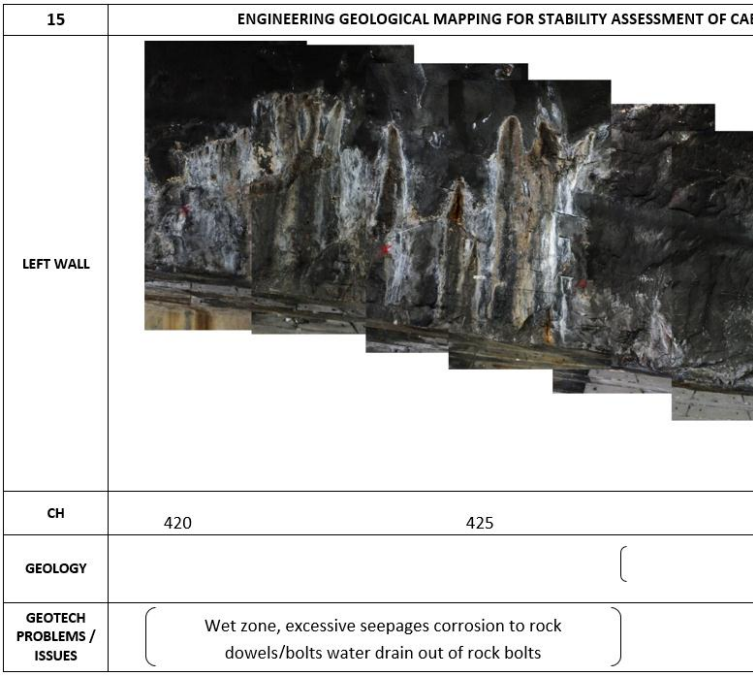
Fig. 3). Both sides of tunnel (right and left side of the wall) was captured and stitched together manually in Corel Draw software. The length of area covered in specific areas vary, depending on the size of the picture. These photographs are used as base maps during field mapping. Major geological features, in this case water intrusion location along the tunnel, was recorded in the mosaic photograph.

Fig. 3: Example of tunnel mapping conducted during field assessment

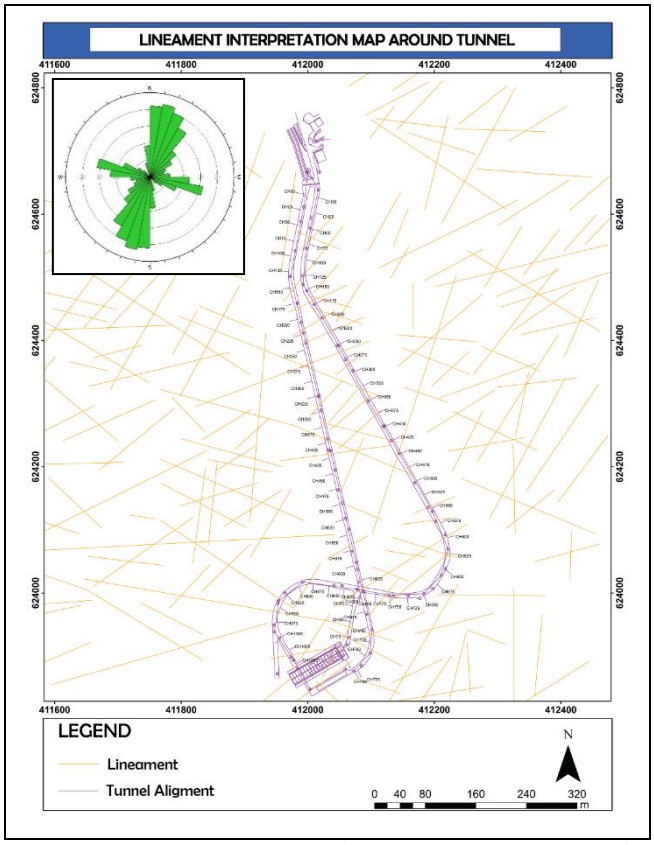
Lineaments are often apparent in geological or topographic maps and can appear obvious on aerial photographs or satellite images [21]. Lineaments represent zones or planes of weakness in the rock mass along the offset bedrock that have undergone accelerated weathering and erosion, and provide the preferred path for water percolation or dissolution to take place in soluble rocks like limestone and dolomite. The satellite image interpretation shows a well-developed lineament system in this area (Fig. 4). From the resultant rose diagrams, the number of major lineament sets can be readily visualized. Four sets of lineaments can be encountered in study area which are oriented in NW-SE, NE-SW, E-W and N-S. However, the most predominant sets are the NW-SE and NE-SW lineaments.

Fig. 4: Lineament interpretation map from satellite image. Four sets of lineaments oriented in NW-SE, NE-SW, E-W and N-S as shown in rose diagram

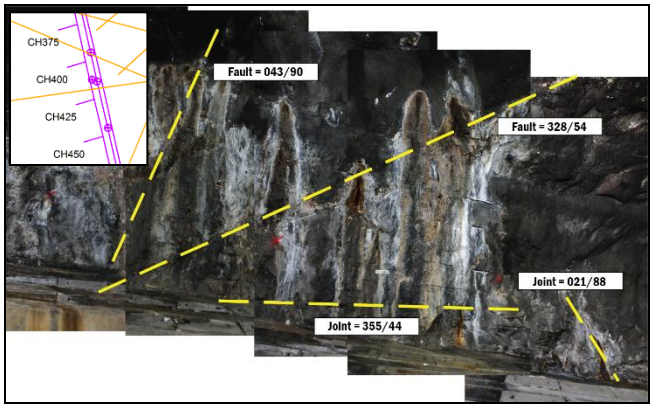
Generally, lineaments features are existing from along both tunnel (main and ventilation tunnel), but more focussed from CH 50-375 and CH 550-800 in the main tunnel. Other parts of tunnel are slightly effected by lineaments, while for ventilation tunnel, lineaments are mostly concentrated from CH 150-275, CH 325-400 and CH 625-725. The correctness of lineament interpretation is verified at the site. Based on the structural mapping in the field, these lineaments sets correspond to the faults and major joints (Fig. 5).

Fig. 5: Some fault structure measured in CH 420-425 in ventilation tunnel. These fault zones are represented in the lineament as interpreted in satellite image

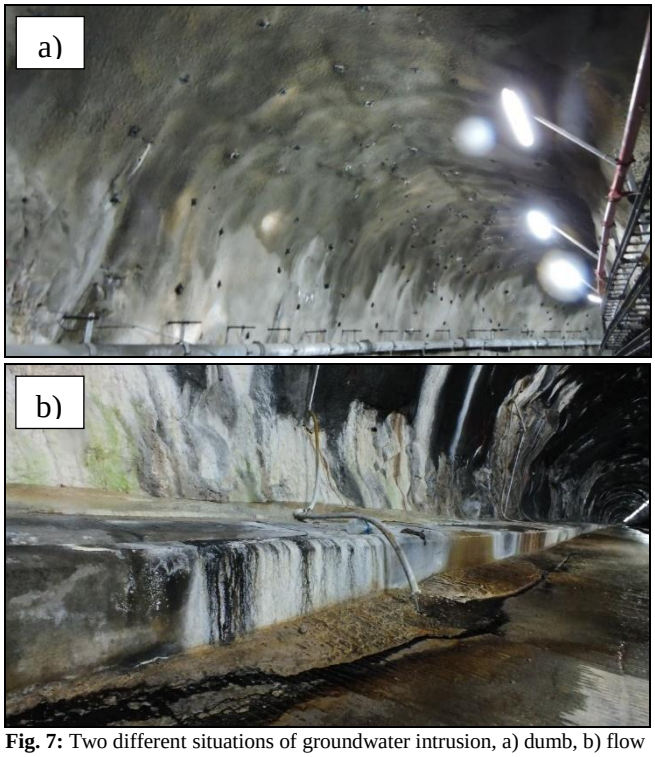
Groundwater intrusion into tunnel is a problematic situation in the study area. Multiple complications associated with groundwater intrusion are identified, examples being corrosion to tunnel support system (Fig. 6), deposition of secondary mineral and clog-up of installed drainage system. Field mapping, to sort and locate water seepages, was conducted from end to end inside the tunnel. Results of water intrusion mapping show significant locations of groundwater intrusion along tunnel. There are five conditions of water intrusion which are: past moisture, dump, standing drop, dripping and flowing (Fig. 7). Flowing and dripping were very common along tunnels, while dump and past moisture were not quite common. The meaning of terms used for groundwater intrusion is explained in Table 1. Calcite mineral deposit is a common feature that can observed at locations of groundwater intrusion. Almost 50% of total length of the tunnel is affected by groundwater intrusion. Intrusion is flowing out from both side of wall and crown (Fig. 8). Summary of groundwater intrusion locations along main and ventilation tunnels are shown in Fig. 9 and Table 2.

Fig. 6: Heavily corroded rock bolt coated by secondary calcite

Fig. 7: Two different situations of groundwater intrusion, a) dumb, b) flow

Fig. 8: Groundwater intrusion can occur either at crown or wall of tunnel. Calcite mineral deposit is a typical feature that can observed at locations of groundwater intrusion

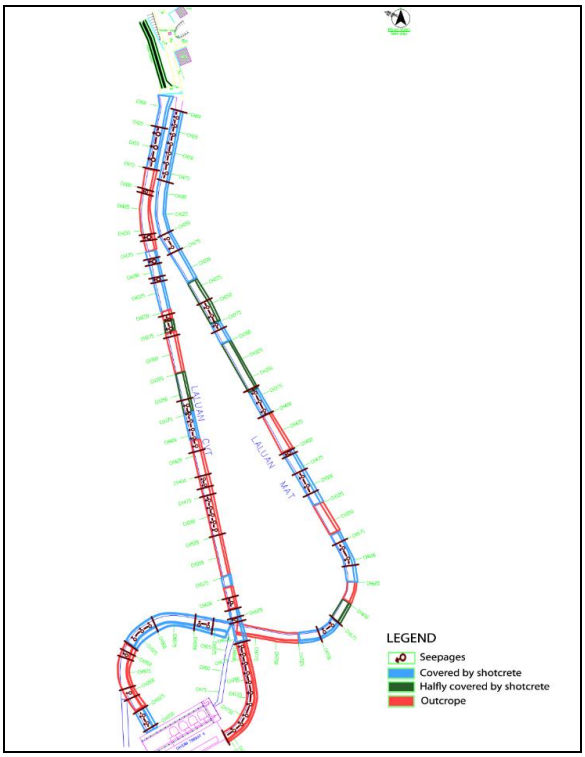
The distribution of groundwater intrusion is not concentrated at certain locations, but it is dispensed along tunnels from end to end. In main tunnel, the area most affected by groundwater is CH 0-80, while in ventilation tunnel, it is predominately at CH 650-780. Other areas affected by groundwater intrusion were the middle of tunnel, mainly at CH 250-275, CH 350-425 and CH 475-525. Groundwater is shown to be flowing along major geological structures, especially joints and faults. Some locations with high intensity of geological structures have excessive amount of groundwater and vice-versa. Other than geological structures, a few intrusions also occur via man-made holes, especially rock bolt and weep holes.

Fig. 9: Summary of water seepages/wet zones along main and ventilation tunnels

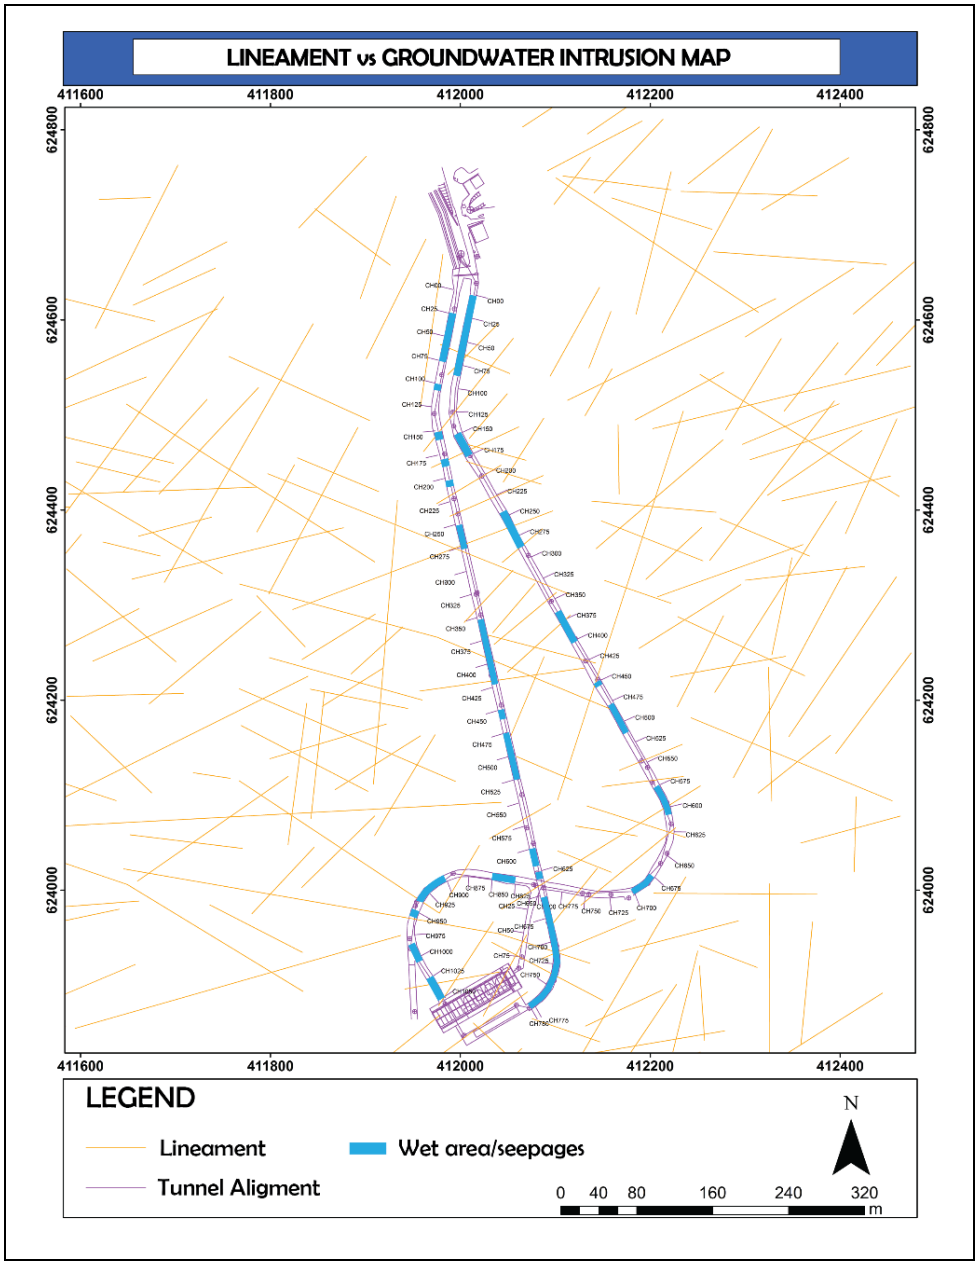
Maps of lineament interpretation and groundwater intrusion are combined together, as shown in Fig. 10. The comparison between lineament and groundwater intrusion shows both data are related to each other. Each section or location where groundwater intrudes into tunnel, presence of lineament(s) can be noticed. Groundwater can flow efficiently through these geological structures, which are well-connected to each other, and thusly increases porosity and permeability. For example, at groundwater intrusion from CH 350-425 in ventilation tunnel, six lineaments are identified to be present. Similar setting also can be seen at other locations along tunnel, for instance from CH 475-525, CH 625-780 in ventilation tunnel and CH 150-175, CH 250-275 and CH 1025-1050 in main tunnel.

The number of lineaments differ from one location to another and it does not influence coverage area of groundwater intrusion into tunnel. For example, total groundwater affected are in main tunnel from CH 0-80 is 80m, but number of lineaments identified at that section are two. However, for 75m length of CH 350-425 in ventilation tunnel, identified lineaments are six. Therefore, it can be concluded that the amount of water flow inside each lineament differ.

Fig. 10: Compilation of lineament and groundwater intrusion map
