Condition Assessment of Fire-Affected RC Slab Via GPR Signal Reflections Analysis and Visual Inspection Method

This study aims to assess the condition of a fire-damaged building for recommendation of repair works. The Institute of Medical Research (IMR) building, in Kuala Lumpur, Malaysia was damaged by fire in April 2011.Visual inspection (VI) is the normal assessment method, but for more accurate results, Ground Penetrating Radar (GPR) signal reflections analysis is employed. The defects analyzed are cracks and delamination of the affected area which was the reinforced concrete (RC) slab at level 3, location where the fire had started. The results obtained using GPR and visual inspection were compared. The area where cracks were detected visually was confirmed by results from the GPR signal reflections analysis but visually, only 28% of the slab area showed delamination defect. When checked with GPR, the area of delamination was actually 56 % of the slab area. Cracks and delamination damage mapping was prepared in order to help facilitate repair works. This result shows that Ground Penetrating Radar (GPR) signal reflections analysis had detected delamination in RC slab where nor

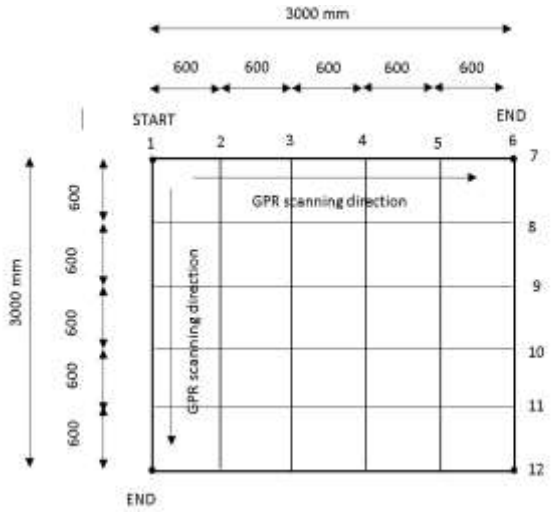
Fig. 3: Grid mark divisions scheme of the slab and GPR scanning direction

The initial investigation work started by defining the working areas with rectangular grid of 3000 mm × 3000 mm on each slab. The working areas (A and B) were marked and grid with a smaller rectangular grid of 600 mm × 600 mm squares as shown in Figure 3. Post-fire slab defects assessment was conducted using GPR by scanning the slabs in two directions perpendicularly as shown in Figure 3.

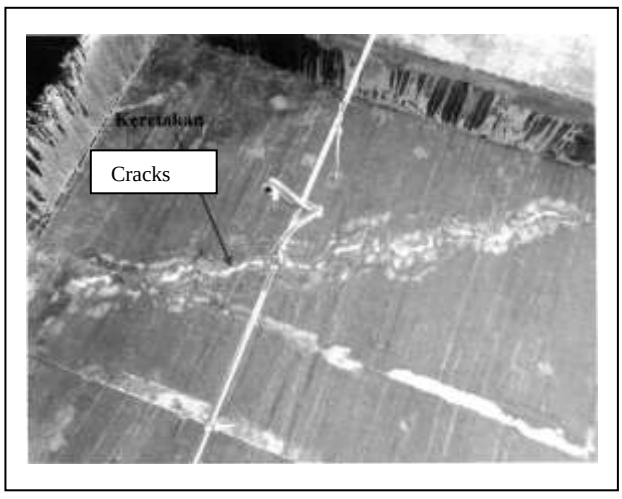
Fig. 4: Delamination at soffit of slab surface

Based on the visual inspection evaluation on both slabs, the concrete delamination was detected at location "A" and cracks were identified in RC slab at location "B". Figure 4 shows the existence of delamination on slab at location "A" and cracks at location "B" are depicted in Figure 5.

The deterioration of both slabs was found on the slab soffit and they were identified as in a critical deterioration state (Rate 4 from Table 1); which needs more detail inspection method to determine the necessary repairing or rehabilitation works to restore the slabs to its original state (Table 2). Rate 4 suggested detail inspection method needs to be done, thus the employment of the GPR signal reflections analysis on the slabs.

Deterioration Type	Surface	Visual inspection grading scale	Severity interpretation
Delamination (Location A)	Soffit of slab	4	Critical
Cracks (Location B)	Soffit of slab	4	Critical

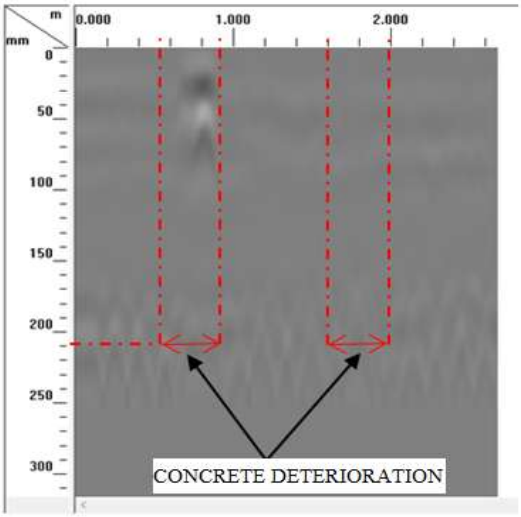
Fig. 6: Subsurface image at location "A"

Figure 6 shows the image taken at grid number 4 at location "A" that has been analysed using RADAN 7 software. It can be seen that hyperbolic reflections wave had appeared at depth of 210 mm, which is the depth of the rebar. The hyperbolic reflections are identified as the rebar. Upon observation of the hyperbolic reflections, weak hyperbolic reflections were detected at distance 550 mm to 950 mm and from 1600 mm to 2000 mm from the initial scanning position, showing there exist different medium (void or rust) other than steel. This hypothesized that the delamination at location "A" is located at depth 210 mm from the soffit slab surface with the length of 400 mm.

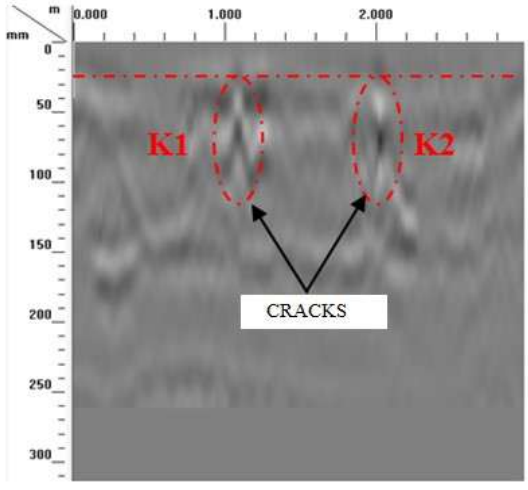
Fig. 7: Subsurface image at location "B"

At location "B" of the slab, cracks images were displayed by a strong hyperbolic feature as shown in Figure 7. This image was taken at grid number 9 at location "B" using GPR and analysed by RADAN 7 software. It can be hypothesized that cracks were initiated from distance of 1100 mm and 2000 mm at depth of 25 mm from the slab soffit surface. The cracks defect was detected based on the travel time difference observed at location marked by the oval (K1 and K2) in Figure 7. At location K1 and K2, the time taken for the wave to travel two ways is shorter than at any other locations, showing different medium other than concrete existed (air - crack).

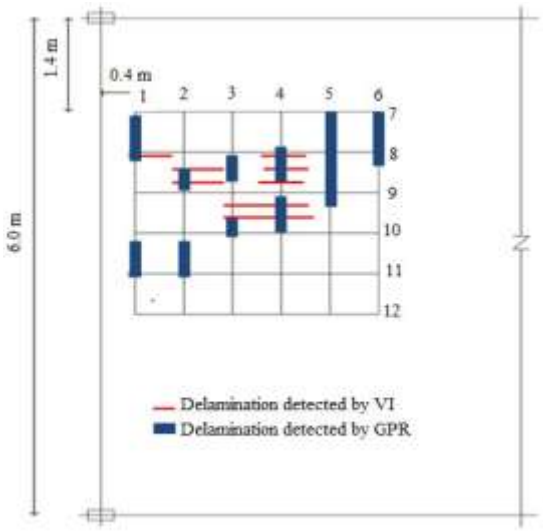
Fig. 8: Comparison of delamination results

Almost 90 % of the detected delamination work done by the visual inspection method were also able to be identified by the GPR inspection work (Figure 8), but more areas where VI does not shows delamination were detected by GPR. It can be seen that the delamination damage than can be detected by GPR inspection work is 56 % of the slab area, while visual inspection method only captured the similar damage type at less locations, only 28 % of the slab. This shows that GPR can detect delaminations of rebar under concrete cover, where our eyes fail to see them.

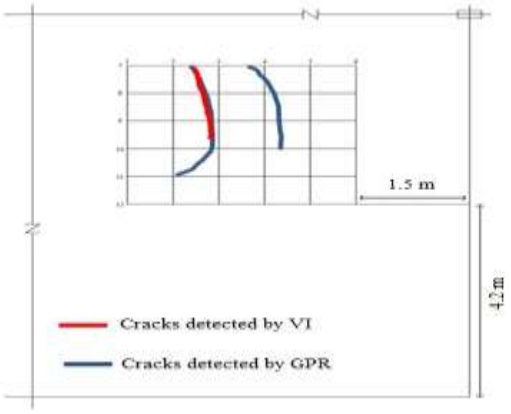
Fig. 9: Comparison of crack detection results

During VI, one crack with 1.5-meter length was found on the slab soffit surface (Figure 5). However, the 1.5-meter length actually extend up to 2.4 meter as shown in Figure 9, detected by GPR measurement and another a 1.8-meter length crack actually was also detected in the reinforced concrete slab using GPR, which is not visible to the naked eyes. This also concludes that GPR can detect cracks inside concrete, which could not be detected by VI.
