International Journal of Engineering & Technology, 8 (1.12) (2019) 55-58

Ten Years Road Maintenance Activity and Forecast: A Case Study

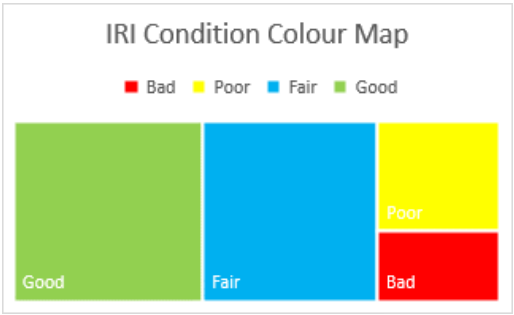
All The output obtained was benchmarked according to Key Performance Indicator (KPI). For some of the conditions, colour mapping was used in representing the health of the roads. These colour maps able to clearly indicates the severity of the damages, and capable of helping the authority to decide on the type of maintenance to be implemented.
For roughness, roads roughness is measured in accordance to International Roughness Index (IRI). Based on the data obtained shown in figure 1, almost 38% of the roads are in good condition and an amount of 36% are found to be in fair condition. 15% were found to be at poor state and 9.7% is in bad shape. This indicates immediate correction action required due to almost 10% of the road are in bad shape (were marked as “red” region during the test). This is the first advantage of having these type of test, where it allows us to understand the health of the road in term of roughness, and how much is required in immediate or preventive maintenance.

Fig. 1: IRI rating colour map based on the condition of the roads.

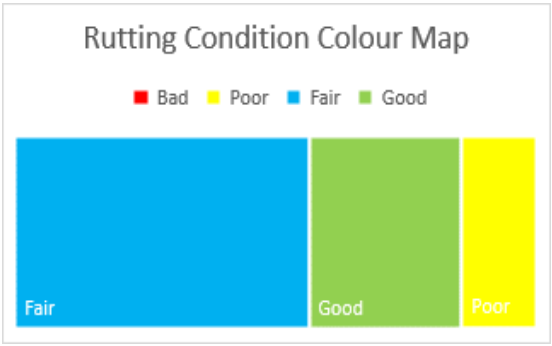
In term of rutting, based obtained data, 56% of the roads are in “good” condition, indicating no rutting presence in the said area. However, a percentage of 14% of roads are in poor condition in term of rutting. This indicates that some of the financial requirements are required to be allocated to this area in order to improve the rutting condition. Based on this map shown in figure 2, the bad condition is negligible.

Fig. 2: Rutting condition colour map based on the condition of the roads.

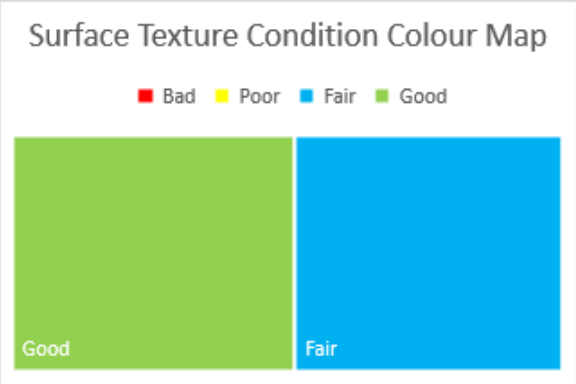
Meanwhile, analysis in form of surface texture, 51% of the road surface were found in "good" condition. Not visible in figure 3, a negligible 0.04% of the roads, an amount of 0.04 km, is in poor condition. This indicates no major corrective action is required in term of the surface texture, hence allowing the funding to be utilised on other more critical areas.

Fig. 3: Surface texture colour map based on the condition of the roads.

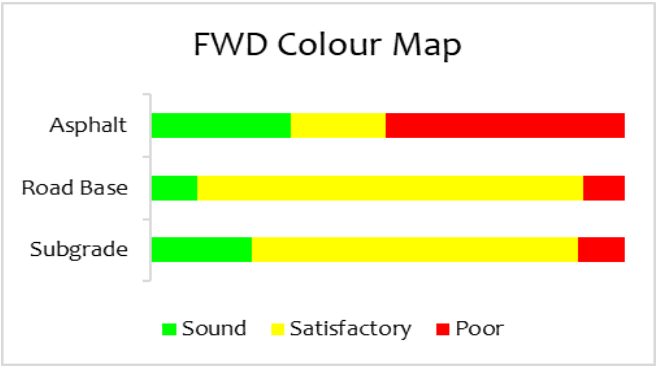
Any deflections that yields a value greater than 500 microns is considered as poor performance. Should the lower layer profile is the same with the rest it indicates that the layers are uniform [10]. However, if the deflections are not similar in between layers, the layers are dissimilar in characteristic. According to the falling weight deflectometer test, the asphalt layer shows 29% in "sound" category while almost 50% is in "poor" category. However, in road base layer, most of the roads are on "satisfactory" level with 82%. On subgrade layer, 68% is on "satisfactory" level. This indicates that only preventive maintenance is required on the most part of the roads. The deflections are represented by the colour map in figure 4.

Fig. 4: FWD colour map based on the condition of the roads.

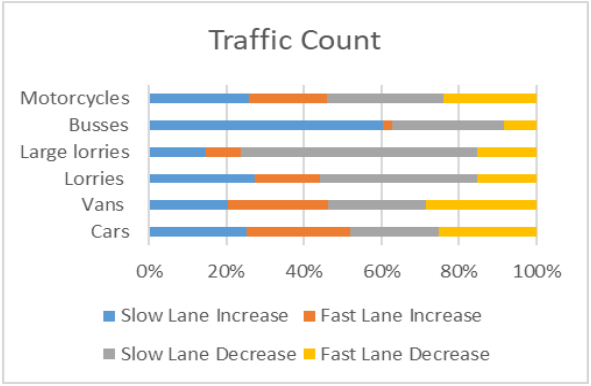
Prior to the study, two specific locations were identified and axle load survey was conducted. The test was done within 32 hours with 16 hours on each direction, covering both directions. 169 commercial vehicles were recorded with an equivalent factor of 0.370 (increasing bound) and 151 commercial vehicles with an equivalent factor of 0.562 on the decreasing bound. A total vehicle of almost 6000 were recorded within 24 hours in the slow lane, while 6640 were recorded on the fast lane for increasing direction. For decreasing direction, almost 3700 were recorded on the slow lane with 6369 on the fast lane, as shown in figure 5. This shows that the roads are in mild density and this can place consideration on the priority of the preventive maintenance to be carried out within this district.

Fig. 5: Axle survey details of the location
