International Journal of Engineering & Technology, 7 (2) (2018) 305-309

Vegetation growth impacts conveyance efficiency of irrigation canals - a geo-drone approach

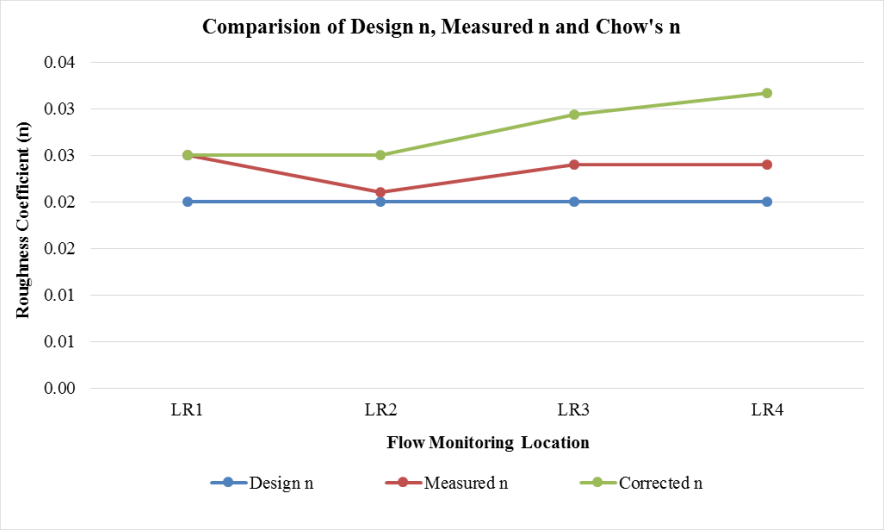
Fig. 2: Comparison of Design N, Measured N and Chow's Method N.

The Manning's n corrected with help site condition as per values are given by Chow (1983) for weed factor. However, both of these n values show, due to exiting conditions of the canal, roughness is increased and velocity has been decreased considerably. The Figure 2 shows the comparison between design n, measured n and Chow's n.

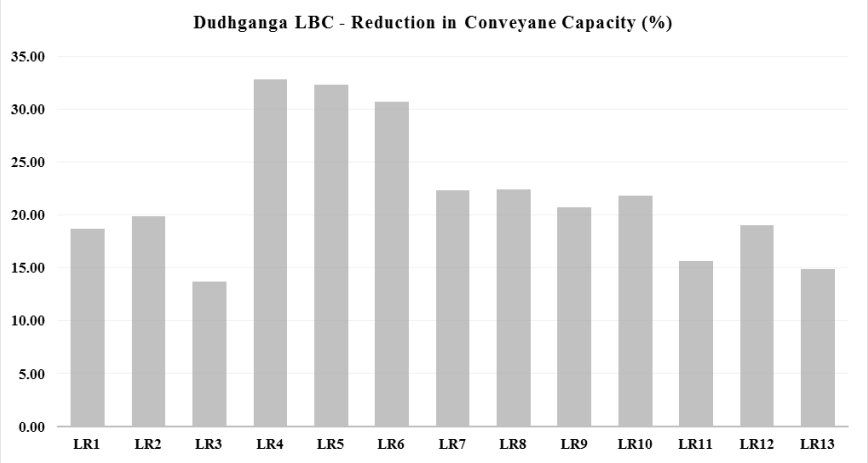
Fig. 3: Reduction in Conveyance Capacity (%) for Dudhganga LBC.

Each section of Left Bank Main canal had issues with aquatic weeds with variable densities along with other issues which affect the canal functioning. After using the corrected Manning's roughness values based on Chow's weed factor, overall 21.90% reduction observed in canal conveyance capacity. The Figure 3 shows the percent change in conveyance capacity comparing with a design capacity for each reach. Reach LR4 has a maximum reduction in conveyance capacity as 32.82%.

The analysis carried in this study will help canal managing group to plan their maintenance work based on the results estimated for each reach. The study shows, the sections LR4, LR5, and LR6 should be planned for maintenance on priority.
