Assessment of the Structure Failure of the Palm Oil Mill Effluent (POME) Digestion Tank Constructed on Peat Soil

Abstract

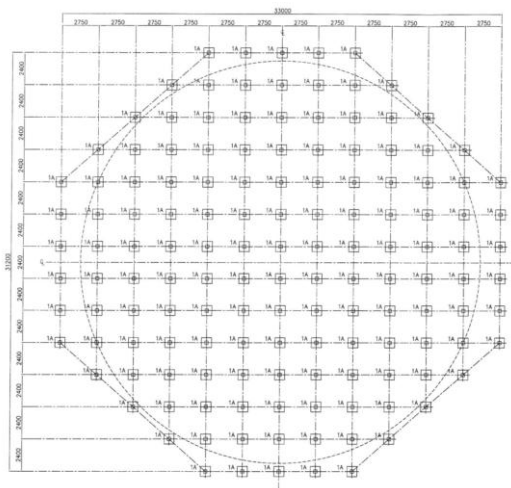
Fig. 1: Layout of piles of the digestion POME tank

Meanwhile, the size of pile caps on top of all piles as 750 mm x 750 mm. Rao (2010) stated that pile caps should be large enough to have a minimum edge distance of 100–150mm of concrete beyond the outside face of the exterior piles. In difficult driving conditions where the actual locations of piles may deviate considerably from the required, the edge distance should be increased to provide for such field variations. The layout of the tank and piles are shown in Figure 1.

There are 142 piles were used as the foundation and also as the column for the tank which was driven to the depth between 45 m to 48 m in average. Generally, the piles cannot be driven absolutely vertical and true to position. In other words, generally, the driven piles on peat soil most probably will be deviated and inclined from its intended position. Even in ideal conditions, the centre of a pile head must be allowed to deviate a certain amount from the required location [4]. In addition, the stress mechanism of inclined piles is very complicated with influences resulting from the vertical load, horizontal load or inclined load simultaneously [5]. Furthermore, based on the pile parameters as in Table 1, the relationship of axial load and moment capacity of the pile is graphically shown in Figure 2.

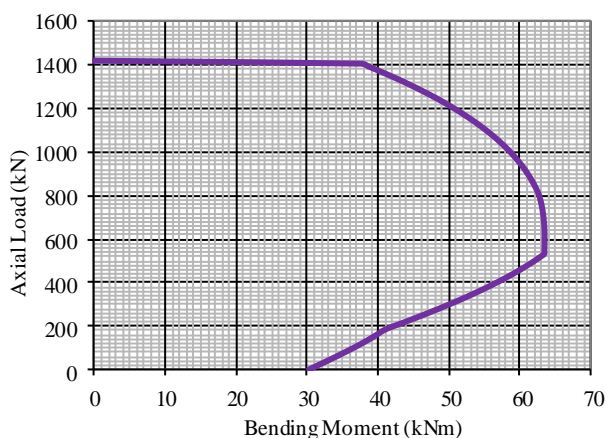
Fig. 2: The relationship of axial load and moment capacity of the pile

The further analysis was done with various loading on each pile for Tank No. 2 which are 100 % loading, 66.67 % loading, 50 % loading, 20 % loading and 0% loading (only dead load – load on tank empty + structure weight) were calculated and the resulted imposed moment on each pile were analysed. The piles were then checked for their allowable moment at the loading based on the graph axial load vs moment capacity as in Figure 2 above.
