Strengthening of the Restored Surface Layer of Steel Parts 45 by Laser Boring

Abstract

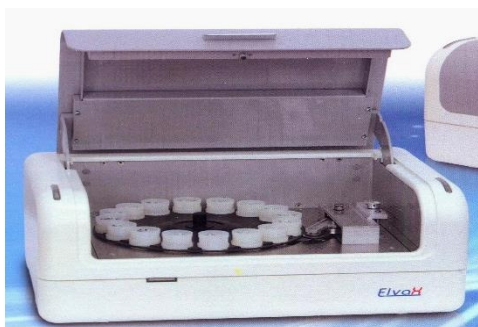
Fig. 3: X-ray fluorescence spectrometer ElvaX 3.

Using an X-ray fluorescence spectrometer ElvaX3 (Fig. 3), an analysis of the components of the restored cams after laser boring was performed. The results of the measurements are in Table 2.

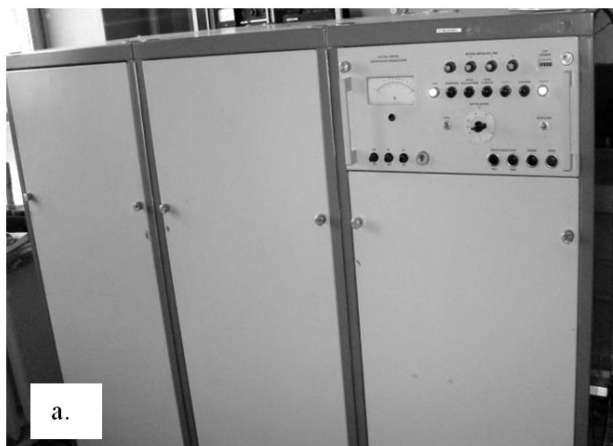
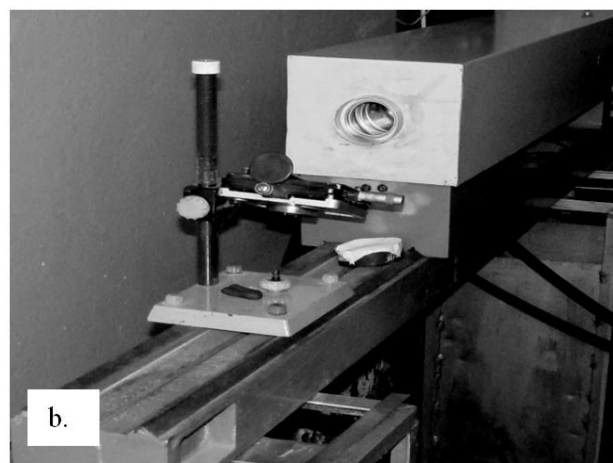
a - a laser control panel; b - laser
Fig. 4: - Solid State Laser GOS 1001.

Laser hardening was carried out on a pulsed solid-state laser GOS-1001. A clear boundary between the primary and secondary boundary layers and the modified layer of the surface of the part is impossible to be carried out because they are in a state of dynamic equilibrium. There is a constant exchange of ions, mass transfer, accompanied by permanent oxidation and thermo-oxidation processes. For heat treatment of the working surface of the cams of internal combustion engines, a pulsed solid-state laser GOS 1001 was used (Fig. 4a, b).

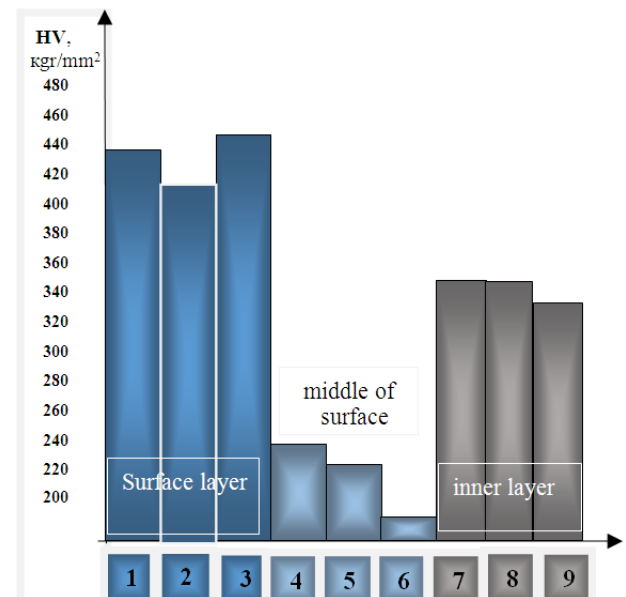
Fig. 6: Microhardness of the surface layer from the largest projection to the center of the body of the cam (zone I).

On Fig. 6 shows that the microhardness of the surface layer after laser boring increased three times (HV350-460) compared with the initial structure of the camshaft of eccentric shaft (HV180-260), which proves the promise of this technology of restoration and strengthening of parts.

The unevenness of the indicators of microhardness (Fig. 6, 7), several different zones on the surface and section of the body of the cam are due to the following factors:

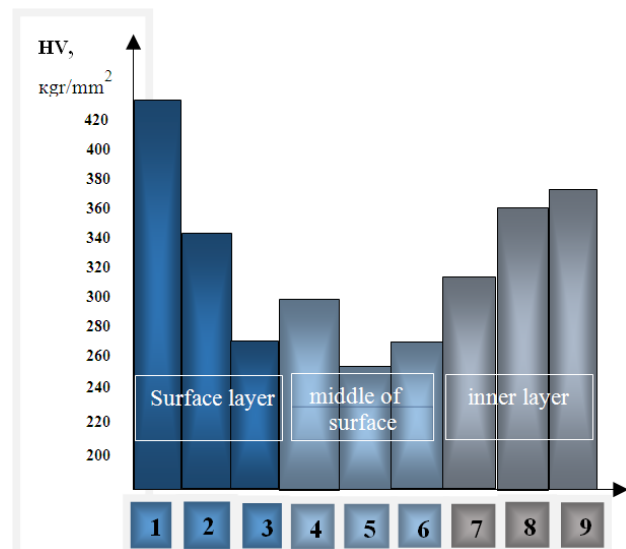
Fig.7: Microhardness of the surface layer from symmetrical paths 2-3 to the center of the body of the claw.

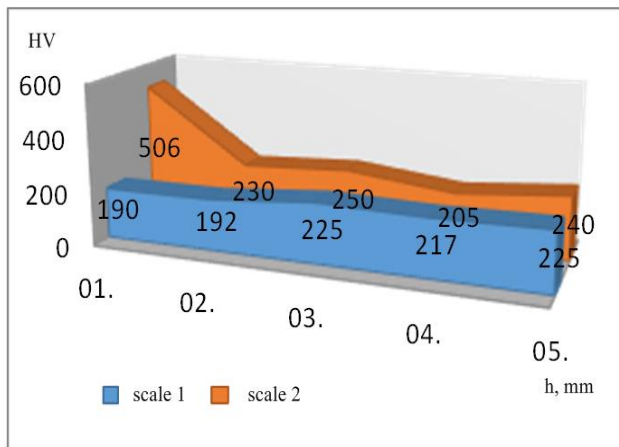
Fig. 8: Microhardness of sample 1 before and after 2 laser borings.

On Fig. 8 graphic dependences of the values of microhardness of steel 45 up to and after restoration with subsequent reinforcement by laser boring are constructed. By the nature of the distribution of values, it can be make that the largest microhardness is observed in the surface layers of the sample. In these layers, as shown by microstructural and X-ray diffraction studies, martensitic structures with a small concentration in them (up to 4-5%) of borides and iron carbides were formed.
