# Radon gas as a constructive element in the chilean pacific coast the case of a manor house in Viña del mar (valparaíso).

The presence of radon gas in buildings is an indicator of indoor air quality. The study presented analyses the amount of radon gas in the city of Viña del Mar in the Valparaíso region (Chile), in a manor house that currently serves as the Center of Advanced Studies at the Universidad de Playa Ancha. Radon gas is an element considered highly harmful to people by various scientific agencies in the field of medicine and health, including the World Health Organization (WHO). The main effect of the presence of radon in the human environment is the risk of lung cancer. This radioactive gaseous element is present in almost all construction materials, and in the land where buildings are located. This article provides the measurements made by the Center of Advanced Studies of the Universidad de Playa Ancha and analyses the levels obtained according to their danger to humans. These values have been used as comparisons to analyse the differences in the presence of this gas between the Chilean Pacific coast and Europe. The values have been analysed with respect to the req

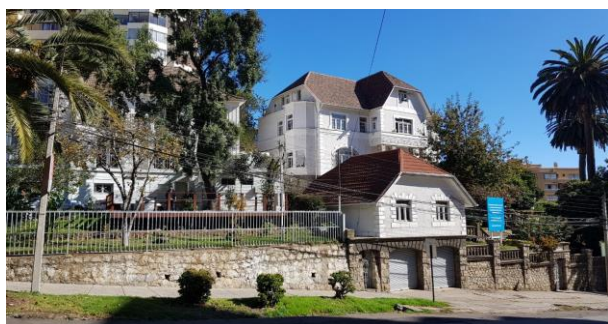
The construction studied on the radon gas indicator present in the interior was a 19th century manor house in the city of Viña del Mar, on the Chilean Pacific coast. This building currently serves as the headquarters of the Universidad de Playa Ancha and the former premises have been converted into research laboratories and management offices. (Fig. 2).

**Fig. 2:** Image of the Building Studied, Located in Traslaviña 450 Street in The City of Viña del Mar. It Currently Serves as the Center of Advanced Studies for the Universidad De Playa Ancha.

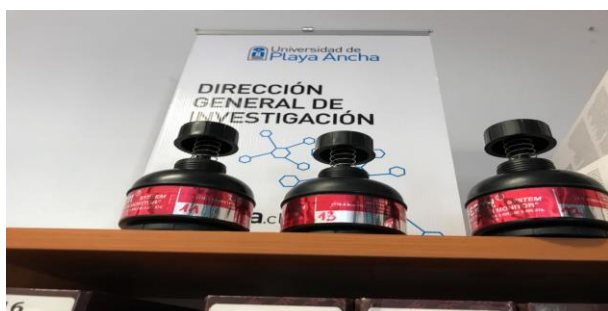
The air quality study conducted with radon gas as an indicator was conducted using Ion Chamber Ionic Electret (CIE), a system that combines a chamber (plastic box of known volume) with a device or electret. CIE chambers are passive devices that function as integrator detectors to measure the average radon gas concentration during the measurement period. The electret works both as an electric field generator and as a sensor in the ion chamber. The radon gas, but not the disintegration products, enters the chamber by diffusion through an inlet equipped with a filter. Radiation emitted by radon and its disintegration products formed inside the chamber ionizes the air contained inside the chamber by reducing the detector surface voltage. A calibration factor then relates this voltage drop to the radon concentration in the space studied. Fig. 3 shows the elements used in one of the areas measured during the study.

**Fig. 3:** Image of the Ionic Chamber of Electrete Placed in One of the Zones of Measurement.
