# Impact of Shoreline Changes to the Coastal Development

## Abstract

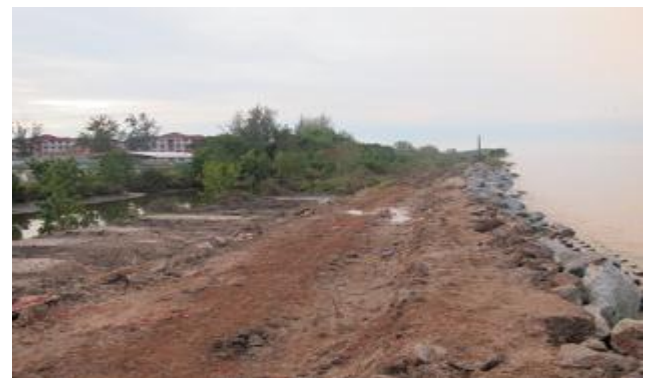
Fig. 6: Eroding shoreline at Sungai Tengi (2016).

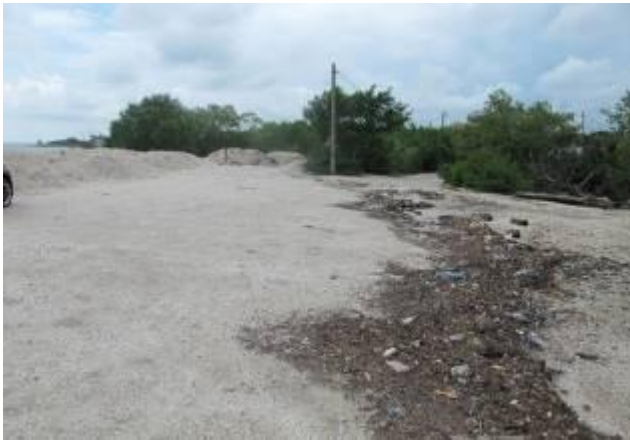
Fig. 7: Accretion shoreline at Bagan Sungai Burung (2016).

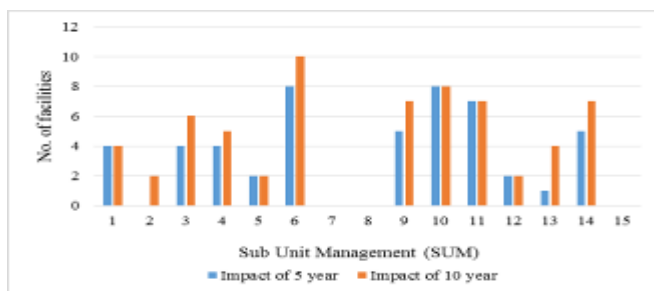
Fig. 8: Destruction facilities impact of shoreline changes for 5 and 10 year projection.

This study was investigated the projection of shoreline changes within 5 and 10 years using shoreline 2013 as a baseline. As for Fig. 8, the results show that in the next 5 years development of SUM 6 will face a high destruction of facilities followed by the SUM 10 area comprising housing, aquaculture, resorts and infrastructures as shown in Fig. 8. Meanwhile, for the 10 years impact, the area that has the most impact on coastal development is also in the SUM 6 area between Sungai Besar and Sungai Haji Dorani. Additionally, the Fig. 8 shows that SUM 7, SUM 8 and SUM 15 areas have not undergone any changes to coastal development from 2018 to 2023. Fig. 9 shows the development at Bagan Nakhoda Omar which will face the highest impact in 2018 and 2023. Reduction of coastal development should be undertaken, there are several management strategies for sea level rise phenomena to be listed for this situation that can occur at any time. This strategy includes provision for inventory before, during and after the occurrence of sea level rise. In addition, each development carried out at the seaside should take into account either long-term or short-term effects.

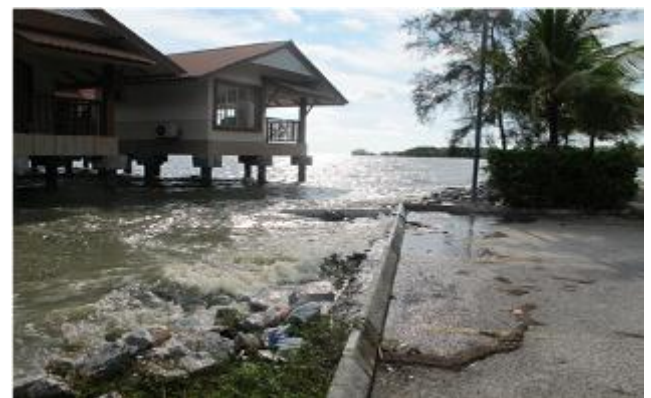
Fig. 9: The current situation shows the development nearest at Sungai Haji Dorani, Haji Dorani Resort (April 2017).
