Impact of Indoor Air Quality by Incorporating Agricultural Waste Into Fired Clay Brick

Noor Amira Sarani¹, Aeslina Abdul Kadir^{2*}, Zaki Muhamad Yusuf³

^{1,2,3}Department of Water and Environmental Engineering, Faculty of Civil and Environmental Engineering, Universiti Tun Hussein Onn Malaysia, 86400 Batu Pahat, Johor, Malaysia

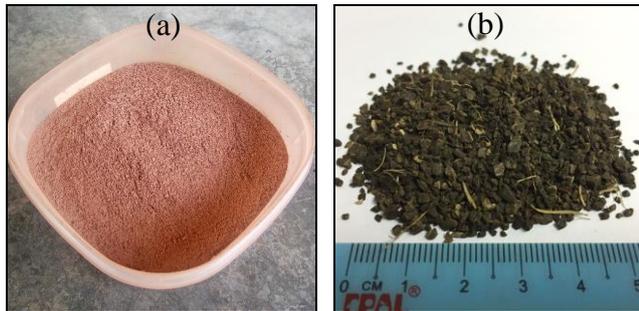
105°C to remove excess water content in the raw materials. After completely dry, both raw materials were grounded and crushed to facilitate the sieving process. The sieve with size of 2 mm aperture was used to yield homogenous size. Fig 1a and Fig 1b show the raw materials after sieving process.

Fig. 1: Grinded of (a) clay soil and (b) PKS

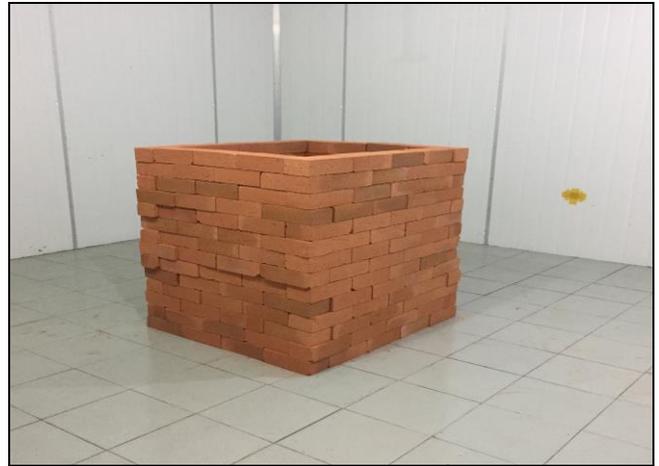
Indoor air quality within and around buildings and structures, especially as it relates to the health and comfort of building occupants. A good indoor air quality can contribute a quality and productivity to the human surrounding. In this experiment, IAQ was conducted in the Walk in Stability Chamber (WiSC) that is isolated from outside air and gases. The Walk in Stability Chamber (WiSC) was thermally insulated designed to be used with a controlled temperature and humidity with the data logger system. It has been designed to study on thermal comfort, heat stress and indoor air quality. The sample of building scaled fired clay brick has been built with a dimension of 1 m x 1 m x 1 m cube (Fig. 2), 0.2 m x 0.1 m x 1.5 m wall (Fig. 3) and 0.5 m x 0.5 m x 1.5 m column (Fig. 4). The data of a sample building scaled fired brick built was collected by using Indoor Environmental Quality Moni-

Fig. 2: Cube pattern

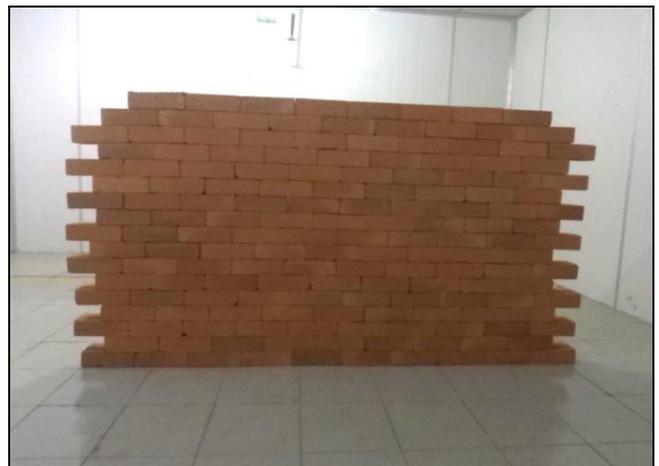
Fig. 3: Wall pattern

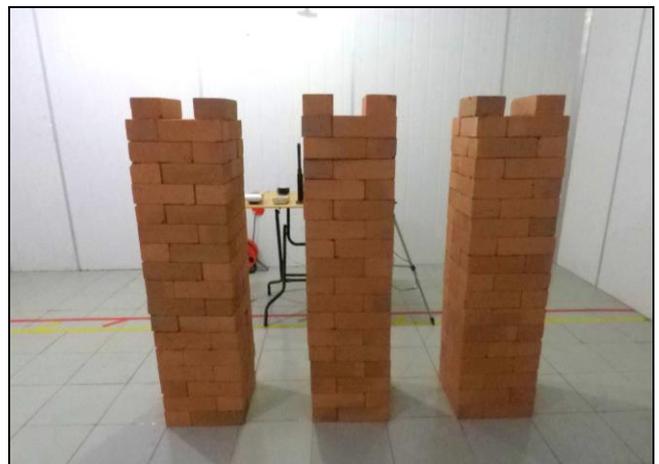
Fig. 4: Column pattern

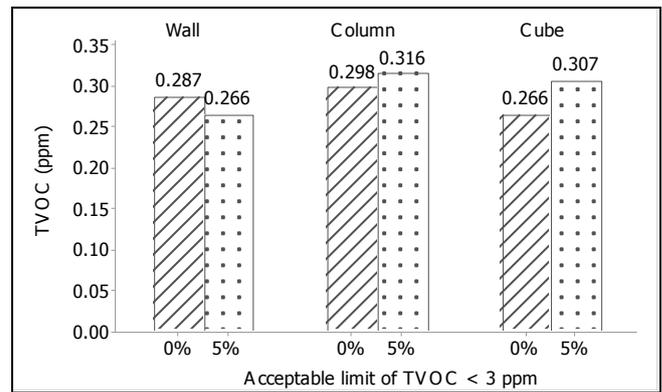
TVOC has emitted gases from particular liquids or solids. Other substances that can contribute to a high of TVOC such as paints, varnishes, wax and fuels and expose to TVOC can cause health problem and cancer. According to [14], the acceptable limits for TVOC is 3 ppm. Fig. 5 shows the TVOC emission from CB and PKSB. From the result, it shows that CB released the lowest TVOC in the form of cube (0.266 ppm), followed by wall (0.287 ppm) and column (0.298 ppm). Another observation for PKSB has shown that wall pattern released lower TVOC compared to cube and column pattern with 0.266 ppm, 0.307 ppm and 0.316 ppm, respectively. As a conclusion, the incorporation 5% of PKS into fired clay brick still does not release high TVOC gases and PKSB is safe to be used as an indoor building material.

Fig. 5: TVOC emission

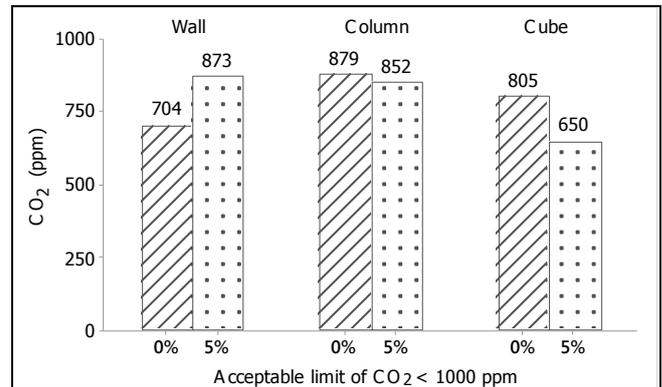
Carbon dioxide (CO_2) is a colourless gas with a density of about 60% higher than dry air and it usually produced respiratory human activities. The excessive CO_2 gases can cause the greenhouse effect that increased earth temperature. According to [14], the acceptable limits for CO_2 are 1000 ppm. Fig. 6 shows the value of CO_2 for the CB and PKSB. Overall, CB0% releases high concentration of CO_2 in column and wall pattern with 879 ppm and 805 ppm, respectively. Meanwhile, CB0% releases low CO_2 at 704 ppm (wall pattern). Contrary to PKSB, CO_2 released high concentration in wall pattern, followed by column and cube pattern with 873 ppm, 852 ppm and 650 ppm, respectively. As a conclusion, all bricks manufactured in this study are safe to be used as building materials in closed structures and meet standard limits below 1000 ppm.

Fig. 6: CO_2 emission

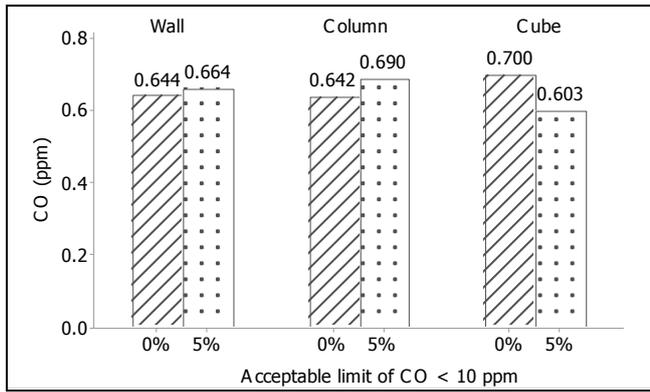
Carbon Monoxide (CO) is a colourless, odourless, and tasteless gas and slightly less dense than air. According to [14], the acceptable limits for CO is 10 ppm. Fig. 7 shows the CO graph value for the CB and PKSB. The result showed that CB has the lowest emissions of CO gases in the form of wall and column pattern with 0.644 ppm and 0.642 ppm, respectively. However, the cube pattern shows the highest release with 0.700 ppm for CB. Meanwhile, analysis for PKSB has shown that the released of CO gases is high in column pattern, followed by wall and cube with 0.690 ppm, 0.664 ppm and 0.603 ppm. Therefore, all pattern for both manufactured bricks did not exceed the allowable limit.

Fig. 7: CO emission

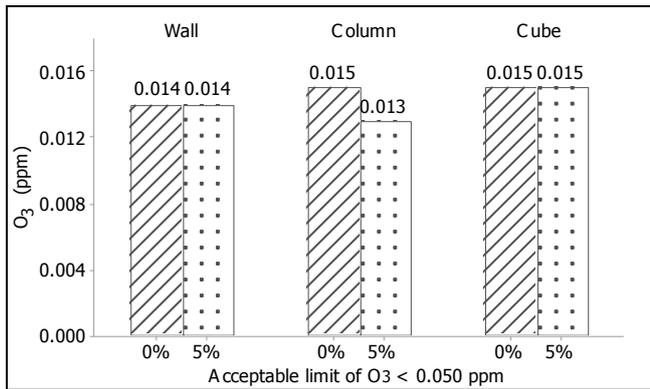
Ozone (O₃) is an inorganic molecule and it is a pale blue gas with a distinctively pungent smell. It also can be found in man-made or their natural state. According to [14], the acceptable limits for O₃ is 0.050 ppm. Fig. 8 shows the comparison of O₃ gases for CB and PKSB. The result shows that CB and PKSB released same level of O₃ gases for both wall and cube pattern with 0.014 ppm and 0.015 ppm, accordingly. Meanwhile, in the form of column pattern, CB released high O₃ compared to PKSB with 0.013 ppm. From this result, the emission of CB in wall and cube form has a constant value. Based on the data obtained, all types of brick samples showed the best results with the lowest emissions. In addition, all the bricks are in compliance with the standards by DOSH (2010) which does not exceed 0.050 ppm.

Fig. 8: O₃ emission

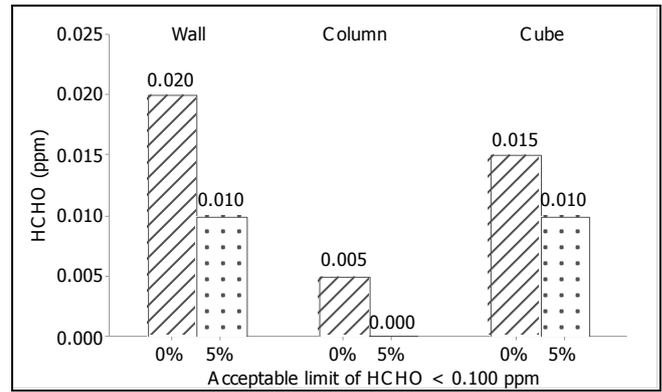
Formaldehyde (HCHO) is a naturally occurring organic compound and it is one of the gases that composed of hydrocarbons and oxidation. According to [14], the acceptable limits of HCHO is 0.100 ppm. Fig. 9 shows the comparison of HCHO released from CB and PKSB. The graph clearly shows that PKSB released the lowest HCHO gas on wall and cube pattern with 0.010 ppm while no gas is released on column pattern. Meanwhile, CB released highest HCHO gases in wall pattern followed by cube and column pattern with 0.020 ppm, 0.015 ppm and 0.005 ppm, respectively. From the result obtained, it was determined that the incorporation of PKS into fired clay brick could reduce the amount of HCHO. However, all bricks are complied with the standards and are safe to be used as indoor building materials.

Fig. 9: HCHO emission

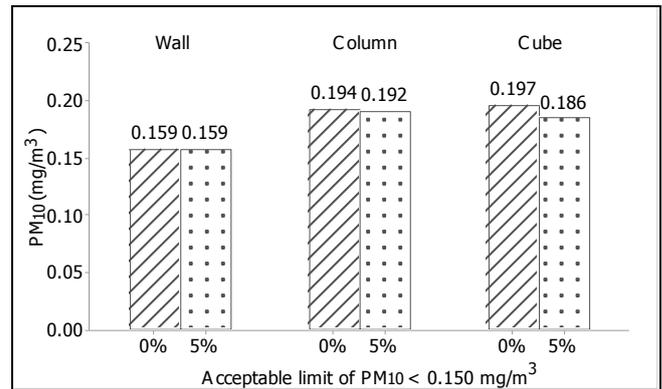
Particulate matter (PM₁₀) is the total of liquid and solid particles suspended in air. This complex mixture includes both inorganic and organic particles such as dust, soot, smoke, pollen, liquid droplets and soot. It came from the industrial activities and open burning as pollutant gases. According to [14], the acceptable limits for PM₁₀ is 0.150 mg/m³. Fig. 10 shows the PM₁₀ for CB and PKSB. From the result, it shows that CB has the highest emissions of PM₁₀ in the cube pattern at 0.197 mg/m³ followed by column and wall pattern with 0.194 mg/m³ and 0.159 mg/m³. Contrary to PKSB, column released high PM₁₀ with 0.192 mg/m³ followed by cube (0.186 mg/m³) and wall (0.159 mg/m³). All the result of PM₁₀ in CB and PKSB is higher than acceptable limit due to result of empty room (ER) that already higher than acceptable limit.

Fig. 10: PM₁₀ emission
