# Abrasion Resistance of Gabion Wires Against Simulated Weathering and Field Conditions

K.K. Tan<sup>1</sup>, C.M. Chan<sup>1\*</sup>, A. Liew<sup>2</sup>

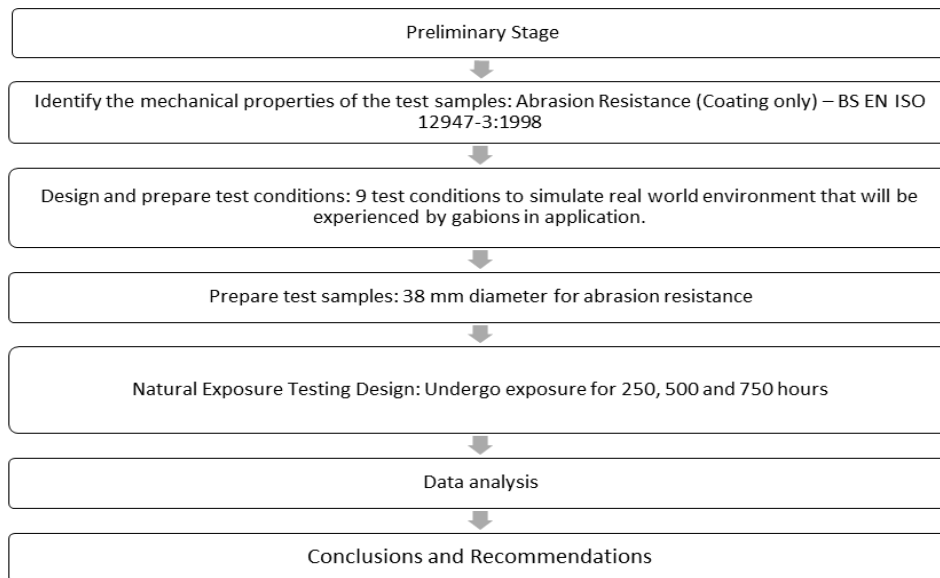
**Fig. 1:** Overall research methodology flow chart of this research

In this study, the focus is on adopting natural/outdoor weathering testing to determine the effect of weathering on the proprietary plastic-based coating by evaluating their mechanical properties change. The mechanical properties evaluated is abrasion resistance. Figure 1 shows the overall research methodology flow chart of this research.

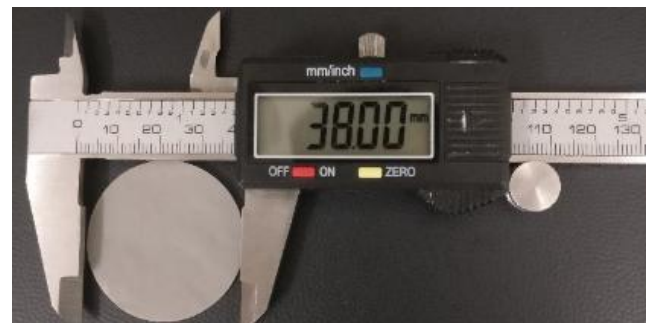
**Fig. 2:** Geometry and dimensions of the abrasion resistance samples

total of 750 hours. Each test required samples of specific dimensions to be installed in the test equipment. The abrasion resistance was determined using the textile abrasion tester as described in BS EN ISO 12947-3:1998. The proprietary plastic-based coating for abrasion resistance samples were manufactured using milling method. The average thickness of the sheet is 1.40 mm. The test samples were cut into circular shape with diameter of 38 mm using a sample cutter (Fig. 2).

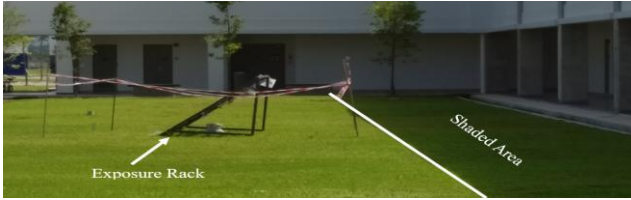
Fig. 3: Test site

The outdoor weathering test was conducted on an empty field located in between Block F and Block G in Universiti Tun Hussein Onn Malaysia (UTHM) Pagoh Campus (2.149N, 102.731E) as shown in Fig. 3 and 4. The testing site was an open field and received sunlight throughout the day without obstruction by nearby structures. The climatic data were monitored.

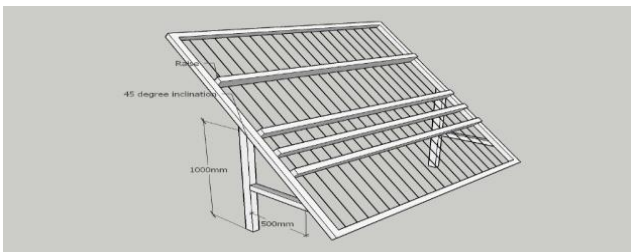
Fig. 5: Design of exposure rack (SketchUp Drawing)

A steel exposure rack was fabricated to hold the test samples throughout the exposure period. The rack was designed to be tilted with exposure angle of 45° from the horizontal (Fig. 5).

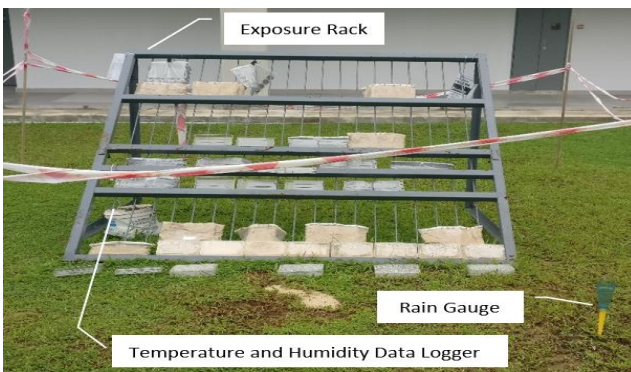
Fig. 6: Complete set-up for outdoor weathering test

In the set-up, monitoring systems were included to observe and record the changes in the variables during the weathering test. The ambient temperature and relative humidity of the test site were measured and recorded automatically by Elitech GSP-6 Temperature and Humidity Data Logger. The rainfall intensity was monitored daily by ClimeMET CM1088 Rain Gauge and data were recorded in the ClimeMET CM5011 Rainfall Chart. Complete set-up was shown in Fig. 6.

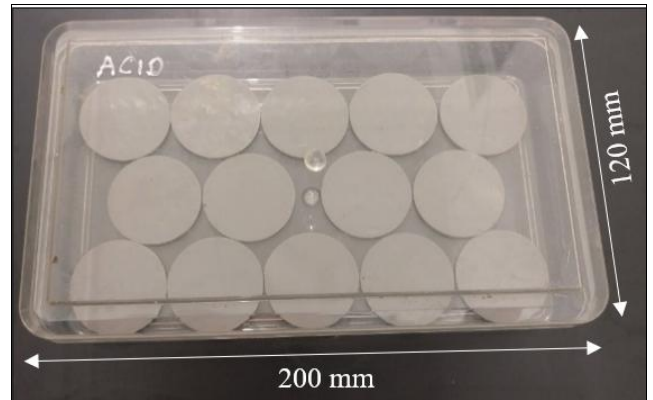
Fig. 7: Abrasion resistance samples

Abrasion resistance samples are placed in clear acrylic container (200 mm X 120 mm X 35 mm) (Fig. 7). The container was chemical resistant and provided with clear cover to minimize the contamination of site conditions. Samples were arranged to prevent any overlapping and to maximize the exposure area.

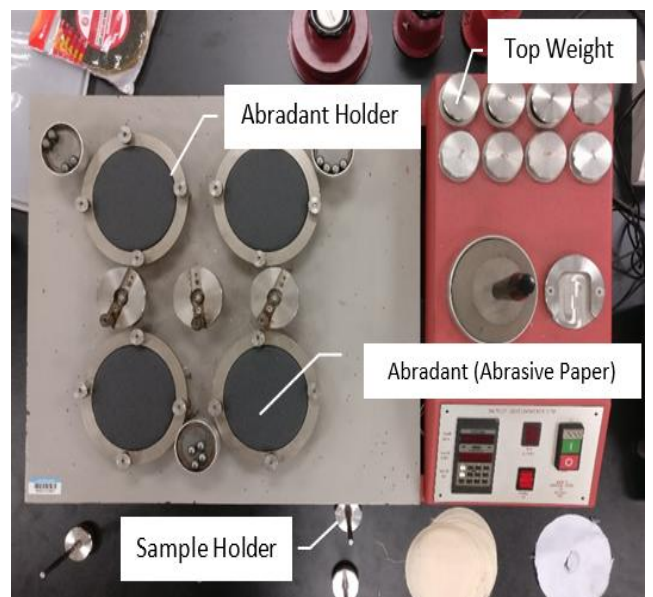
Fig. 8: Abrasion resistance set-up (Without cover)

A set of test samples were tested for abrasion resistance without undergoing any exposure test, i.e. control samples. This was to provide the base results for comparison with the exposed test samples. Abrasive resistance is a test carried out to assess the mass loss from the surface of the coating materials when abraded against an abradant. This test was carried out according to BS EN ISO 12947-3:1998 using a Shirley Developments Abrasion Tester Mark III. Modification was done to replace the fabric sample with coating material and the fabric abradant with abrasive paper (Fig. 8 and 9).

The test samples were weighed to obtain the original mass to 0.01 g accuracy. The circular test samples were then mounted on the sample holders and subjected to 12 kPa top weight. The circular abradants of 140 mm diameter 280-grit silica carbide abrasive papers were mounted in the abradant holders. The test samples were subjected to 1000 rubs against the abrasive medium in a translational movement, tracing a Lissajous figure. The sample holder rotated freely around its own axis perpendicular to the plane of the test sample. The abradant was replaced after every 1000 rubs.

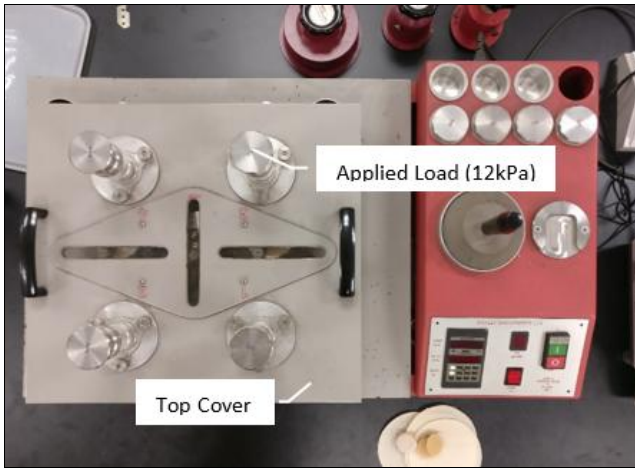
Fig. 9: Abrasion resistance set-up (With cover)

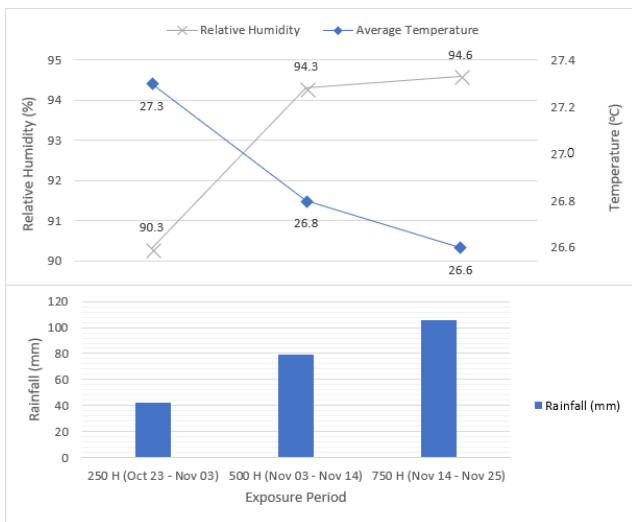
Fig. 10: Average temperature, relative humidity and total rainfall for the exposure site.

Climatic parameters monitored throughout the natural weathering included ambient temperature, relative humidity and rainfall intensity. All parameters were monitored from 23th October 2017, 9.00 a.m. to 25th October 2017, 9.00 a.m. Samples are being tested for the change in abrasion resistance and tensile properties according to modified BS EN ISO 12947-3:1998 and EN ISO 527-3:1995 respectively every 250 hours interval. The test results were compared between the control (unexposed) and the exposed samples. This helps to understand how each site conditions and natural weathering can affect the durability of the PVC coating material. The meteorological data obtained during the weathering period summarized and illustrated in Fig 10.

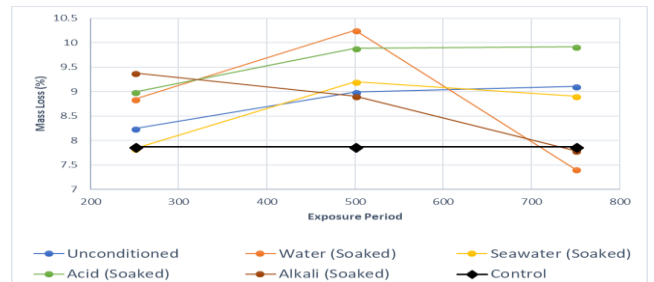
Fig. 11: Comparison of mass loss percentage among soaked samples subjected to different site conditions across 750 exposure hours

The percentage of mass loss of PVC coating samples upon 1000 rubs against 280 grit abrasive paper for soaked and buried samples are shown in Fig 11 and Fig 12 respectively. The percentage of mass loss showed variations from 250 H to 750 H for both soaked and buried samples.

Comparing the soaked, unconditioned samples and control, the unconditioned samples, samples in acid and seawater generally showed an increase in mass loss percentage. Samples in water showed an increase from 250 H to 500 H and experience fall from 500 H to 750 H whereas samples in alkali decreased steadily across 750 H.

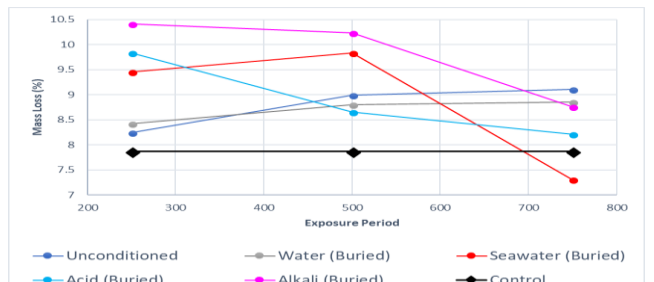
Fig. 12: Comparison of mass loss percentage among buried samples subjected to different site conditions across 750 exposure hours

For buried samples, the results showed similar variation as in soaked samples. Samples in alkali and acid showed continuous decrease in mass loss percentage whereas samples in seawater showed increase from 250 H to 500 H and decreased from 500 H to 750 H. Only samples in water showed continuous increase in mass loss percentage across 750 H.

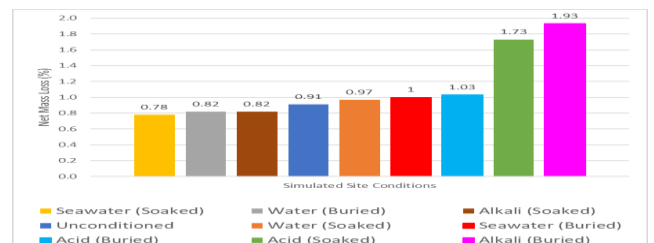
Fig. 13: Net mass loss percentage of different samples

750 hours of outdoor exposure may not be significant compared to 2500 hours of accelerated UVA exposure or 4000 hours of accelerated Xenon Arc exposure as required in BS EN 10223-3:2013 for organic coated gabions. Hence, the mass loss percentage across 750 exposure hours was averaged and shown in Fig. 15 to understand which site conditions have the most effect on the abrasion resistance of PVC coating.

The relatively lower mass loss percentage shown in seawater, alkali and water (soaked) might due to the lack of heat build-up in samples and biofouling of sample surface [9]. Samples exposed to sunlight undergo heat build-up which results in the samples reaching significantly higher temperature than the surrounding air. When air temperature around 26°C to 36°C during the period of exposure, the samples' surface can be much higher, as much as
